# SHORE POINT ARCHITECTURE, PA

## HPC APPLICATION TEXT

Date: November 3, 2022  
SPA Job Number: 2022-19 (Giovanela Residence)  
Property Address: 31-1/2 Heck Avenue (Block 240, Lot 14)

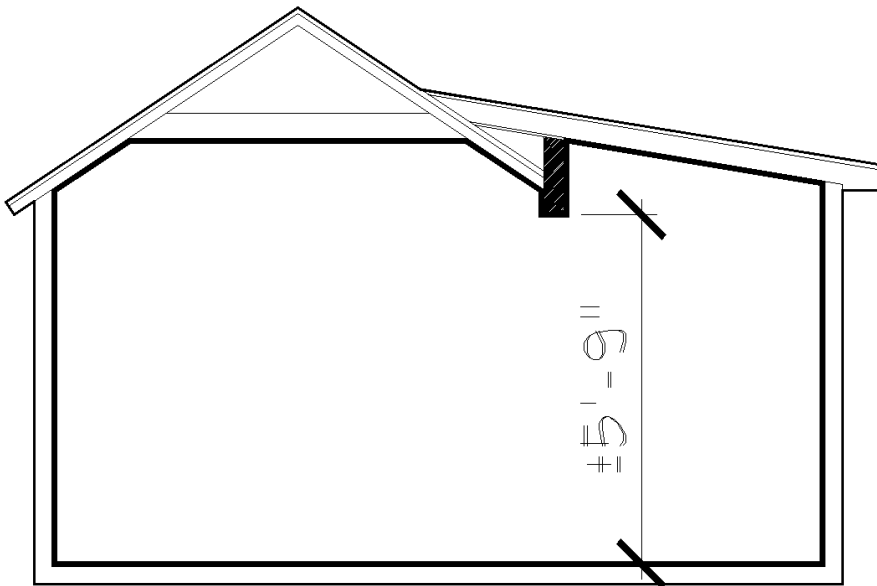
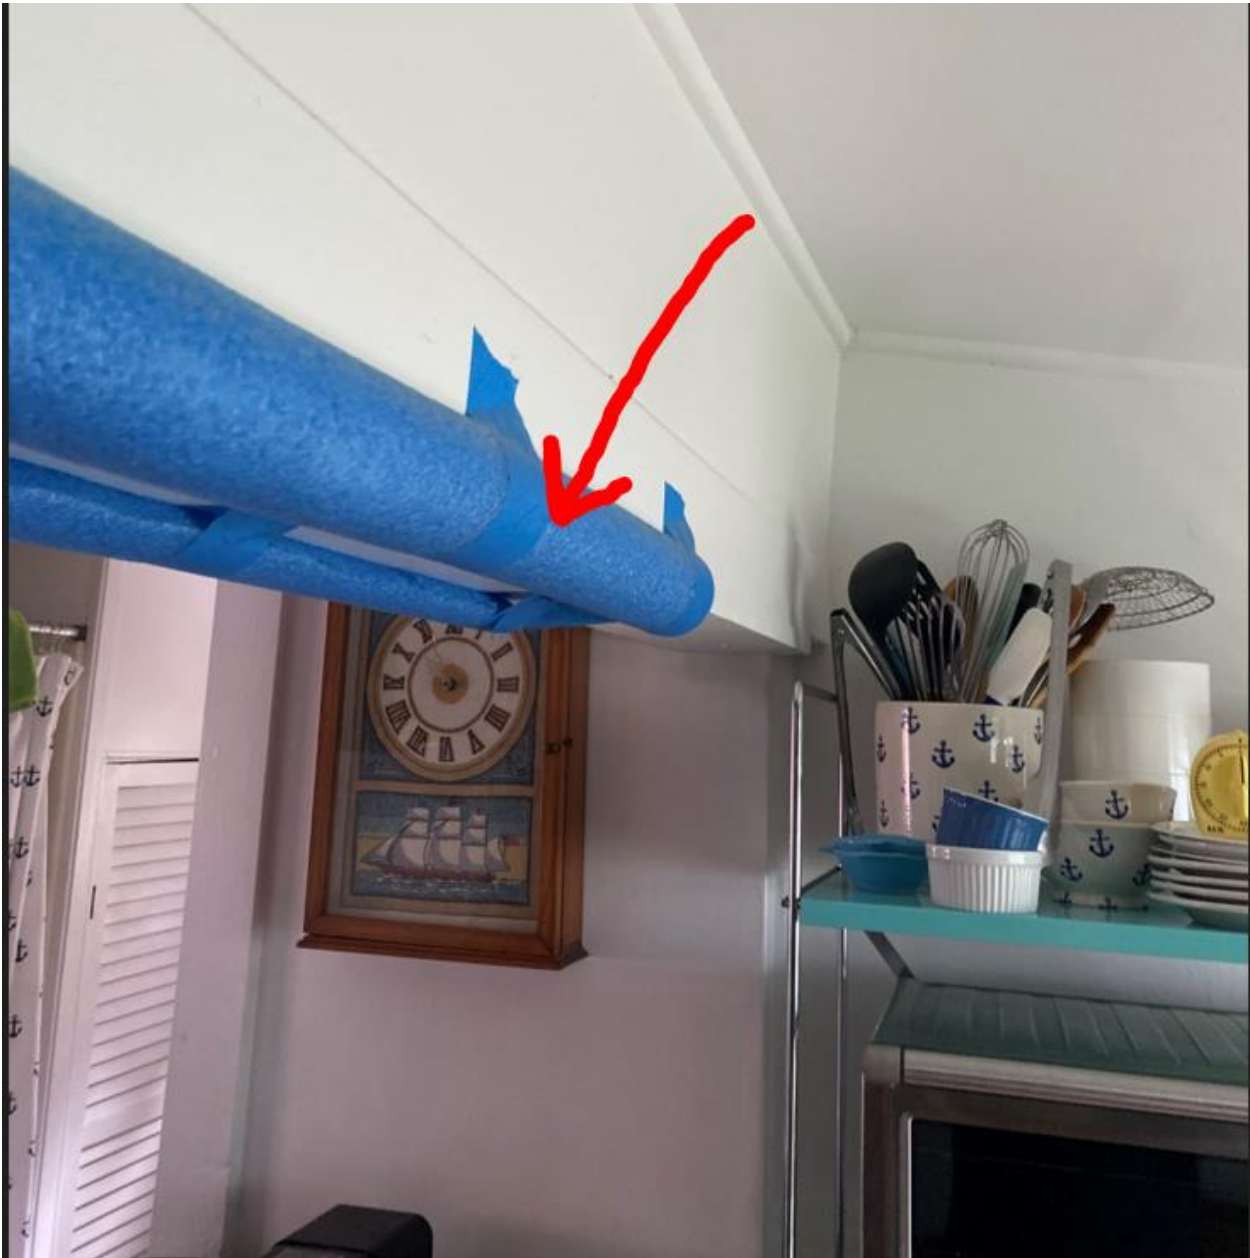
## SIDE ELEV. (EAST)

This area, due to the manner in which it was expanded (after 1950) contains very low headroom, which makes this area unsafe and impractical. Please see diagram below showing the limited headroom. To avoid hitting their heads, the homeowners installed a blue pool noodle to make this projection visibly pronounced.

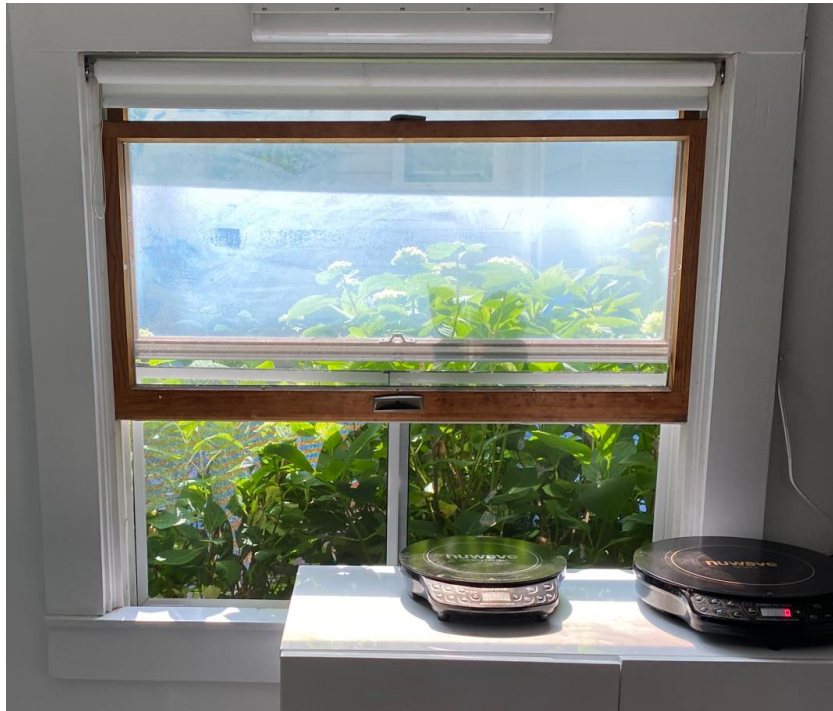
- Window on east side is a newer wood double hung window and is proportionally inconsistent with a window you would expect to see in a (key structure) bungalow style house.

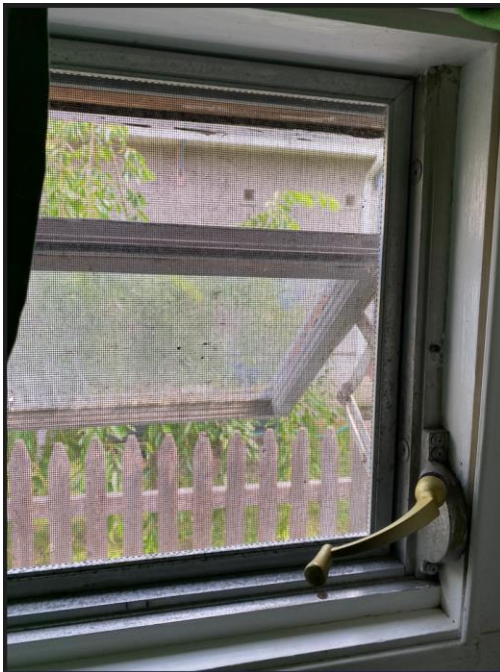
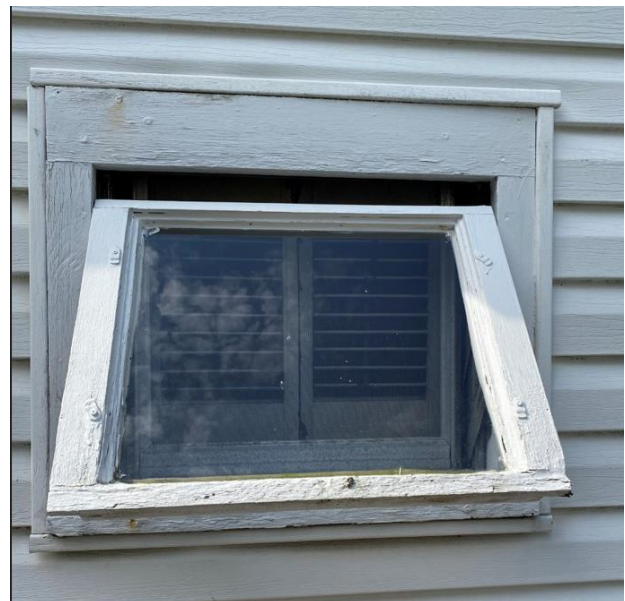
- Two windows at rear are small, square awning windows that were likely installed sometime around 1970. They are proportionally inconsistent with windows you would expect to see in a (key structure) bungalow style house.

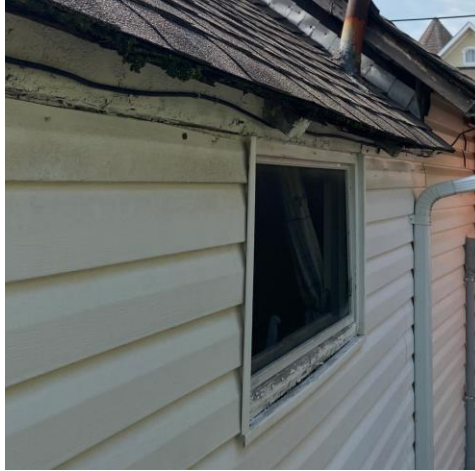
- Window on west side is a wood awning window, likely installed sometime in the 1970's. It is proportionally inconsistent with a window you would expect to see in a (key structure) bungalow style house.

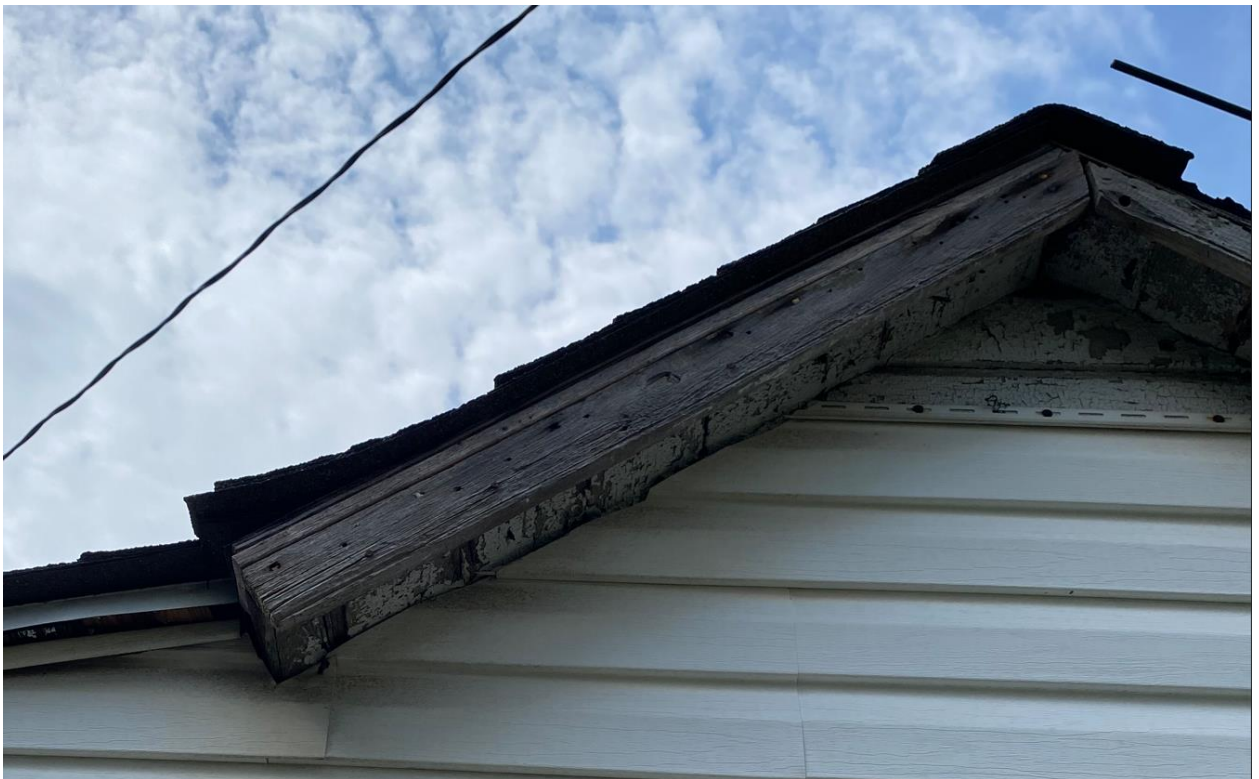
The area scheduled for demolition contains four windows, none of which are architecturally significant. The form of the roof is not original and has been significantly modified after 1960. The addition is clad in vinyl siding and contains exposed rafter ends that display evidence of severe rot. Photos of all conditions mentioned above have been provided below.

- Photo below shows evidence of severe rot and deterioration at existing roof. Upgrades to this area would be practically impossible.
