51 Webb Ave, Ocean Grove
Window Report

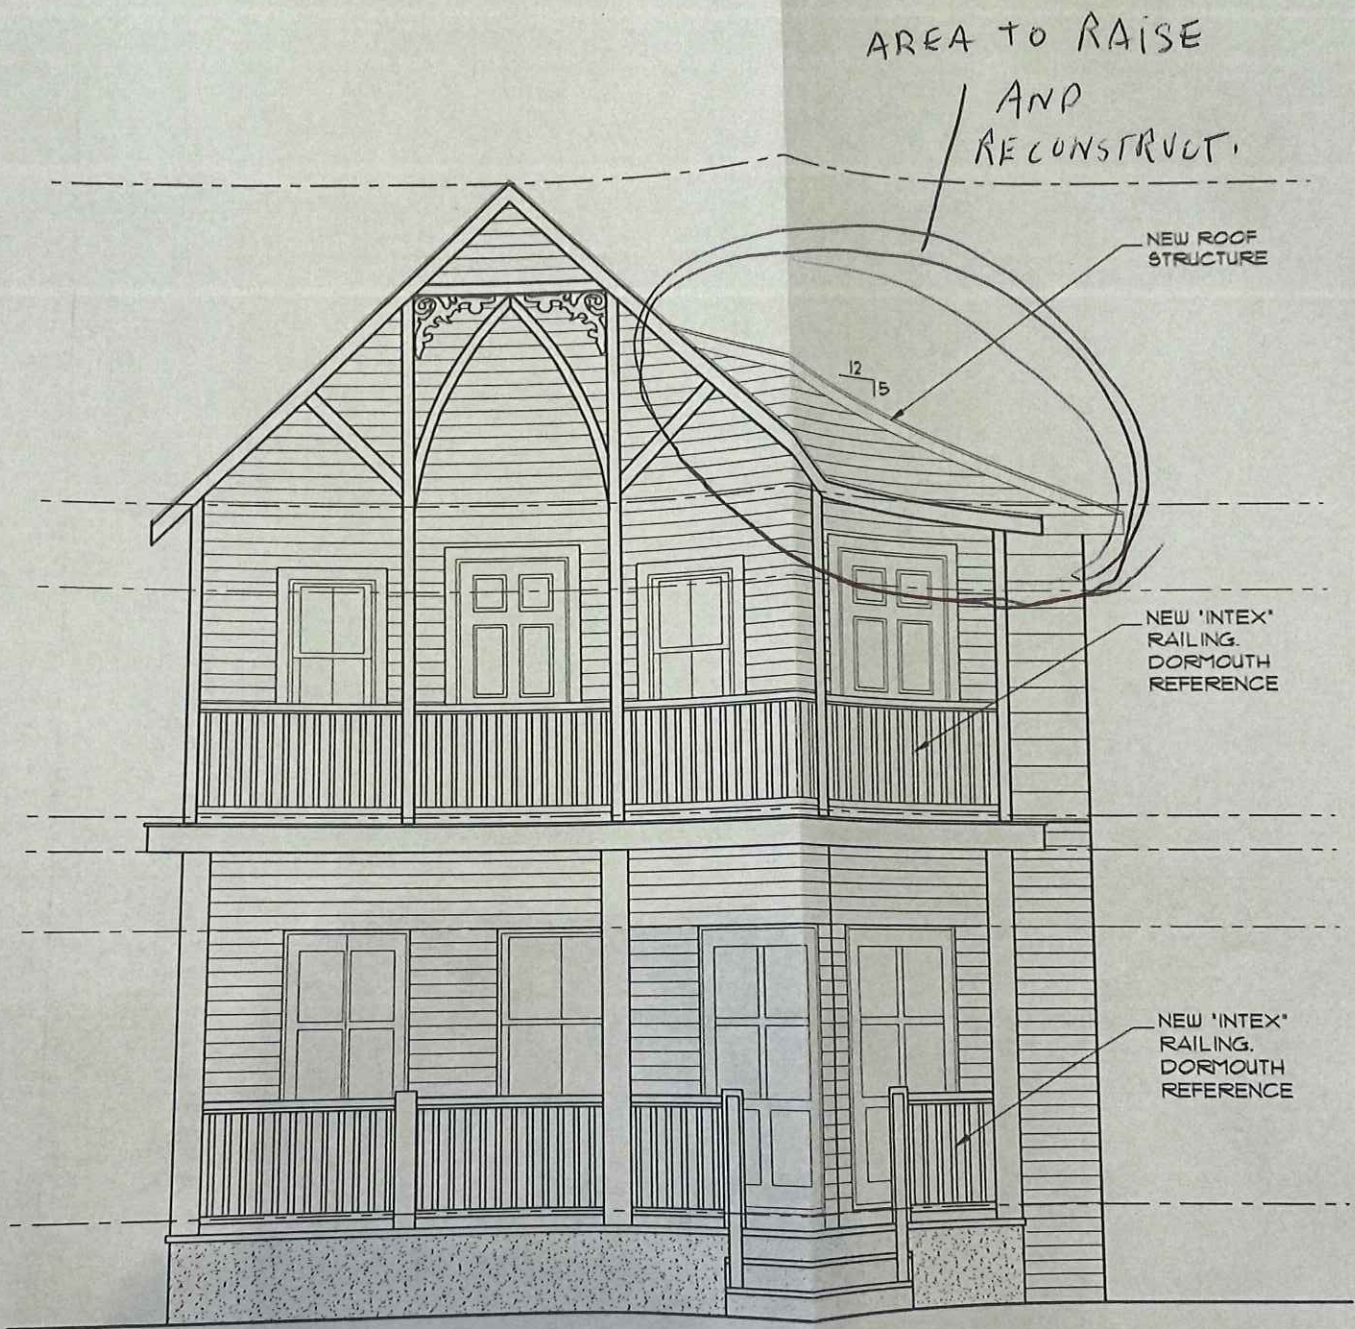
FRONT ELEVATION

- Existing Conditions of Windows
 - Windows are a compilation of Replacement/ Non Original windows and Widows in poor/ non repairable condition.
- 17pc 2 over 2 Double hung window

Over all Condition of windows are Poor and beyond repair. We propose to replace all windows with Anderson 400 Series windows Matching the size of the "Original" Windows.

First Floor -Windows 3,6,11,12,13,15 -(w)30 1/2" X (H)70"

Second Floor- Windows 1,2,4,5,9,8, (W)30 1/2" X (H)51 1/2"

Awning/ Casement - Windows 14,16,10,7- 30' X 30"

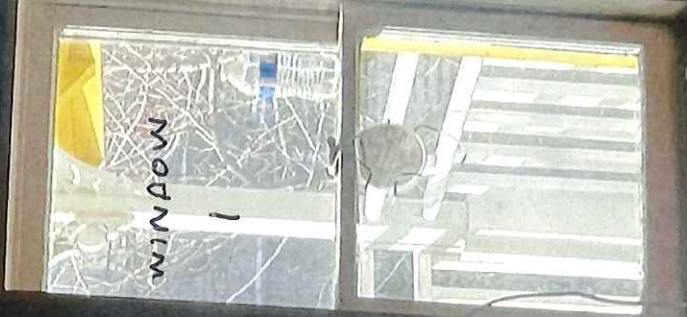
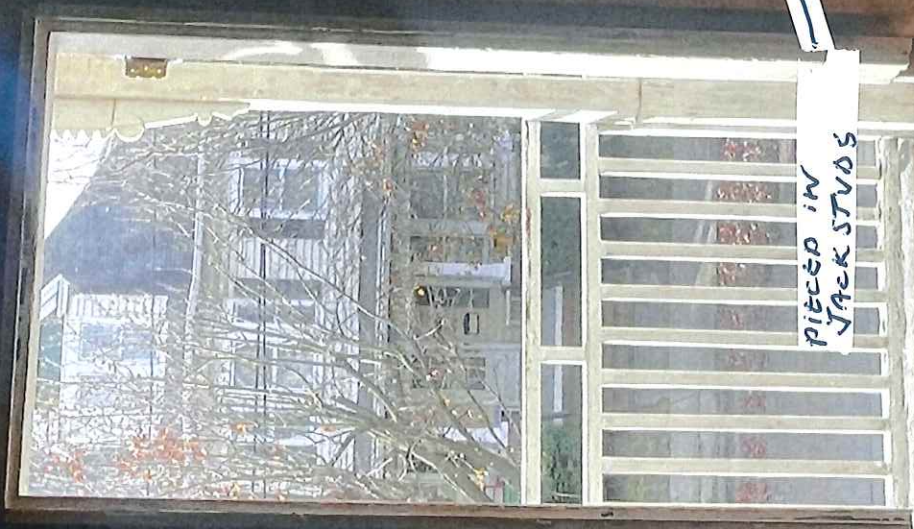
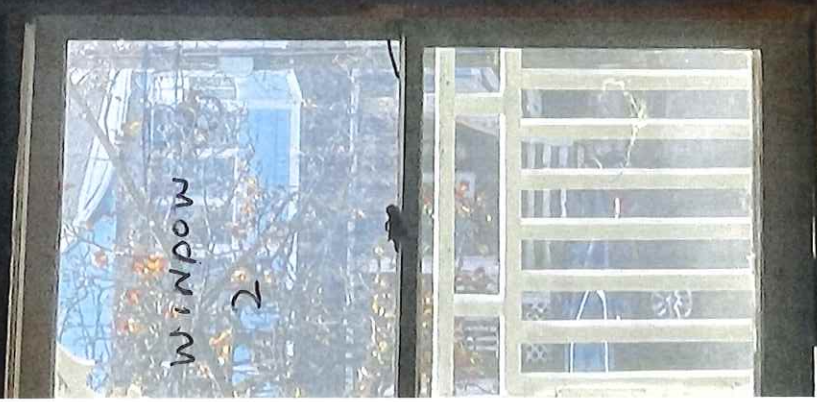
PHOTO 1

- Window 1,2&3 Front of the House(See Photo 1)
 - 1 over 1 double hung windows
 - Small than original window 25 3/4"X 47 1/2" existing window size were 30 1/2"X 51 1/2"

- Different location from original(Looks to have been moved in previous renovation) (No Header above window) Window 3(See Photo 2)
 - Because of the lack of maitnence the windows are beyond repair.

NO SILL
FRAMING

PIECED IN
JACK STUDS

NO HEADER

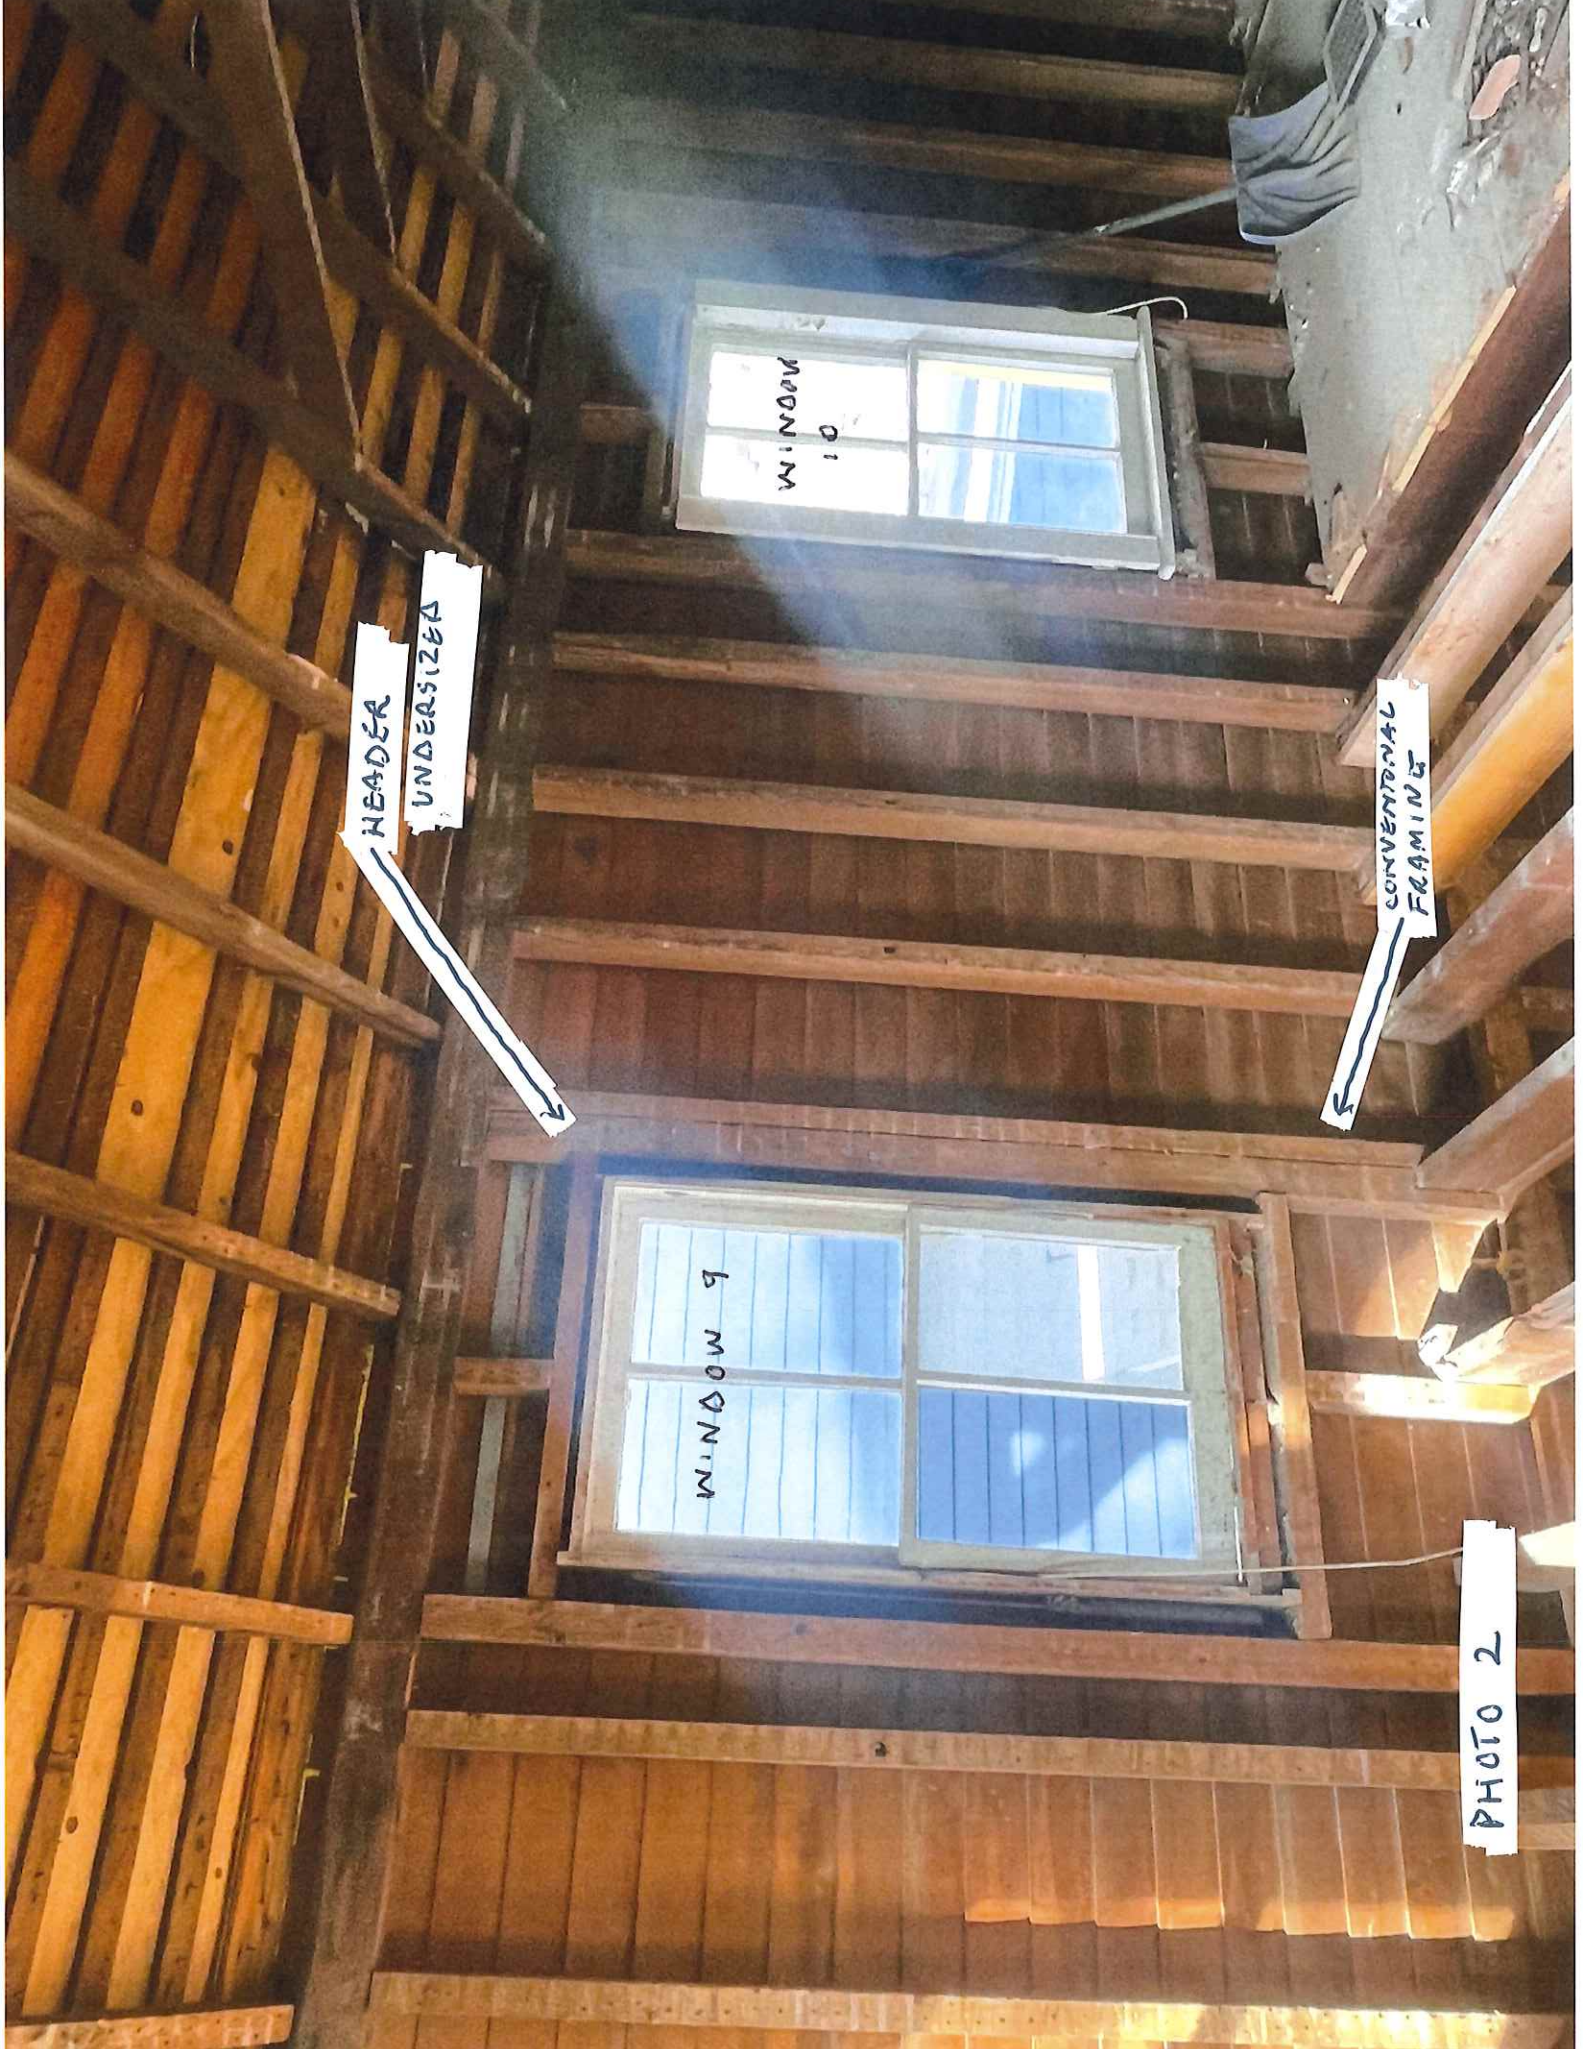
PHOTO 2

- Windows 8&9(See Photo 2)
 - Size 30 1/2"X 51 1/2"
 - Original windows Beyond Repair
 - These see to be the only original windows. These windows are larger and have a 2 over 2 window pattern

- Window 13 seems to be and original widow with size and style. Condition is poor and beyond repair(See Photo 8)
 - Windows 7&10
 - These are newer Casement style windows that look to be installed during a previous renovation.(Window conditions are poor and beyond repair)

HEADER
UNDERSIZED

CONVENTIONAL
FRAMING

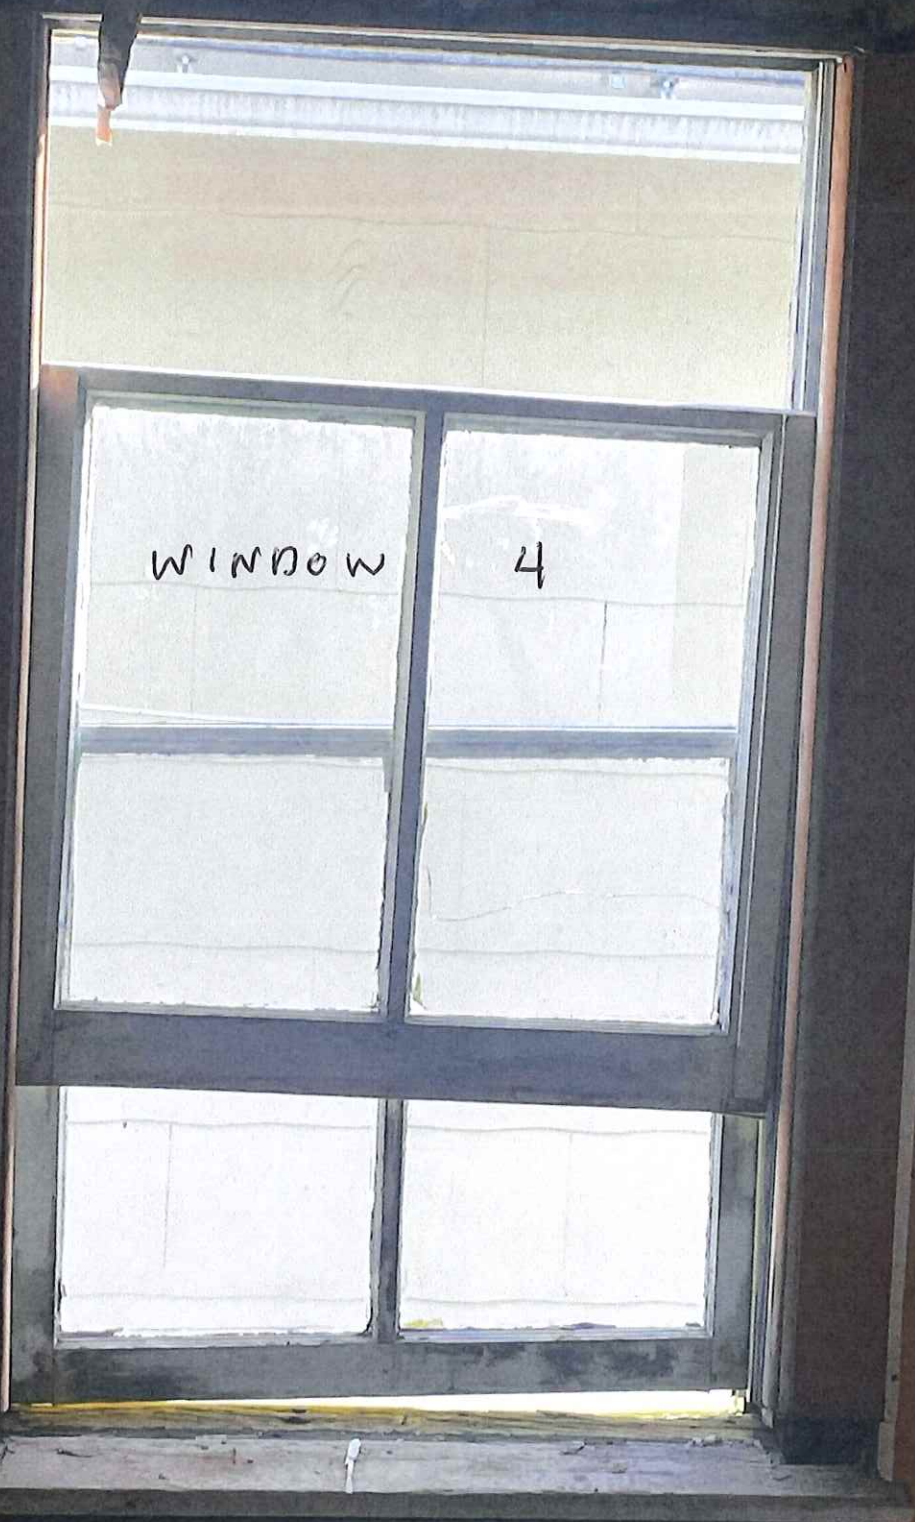
PHOTO 3

- The Wood of the Existing windows is rotting and because of the lack of maintenance the windows are in poor condition beyond repair
 - Window 4,5&6(See Photo 3,4,5&6)

- Window 4&5 are older repurposed windows.(Framing was incorrect and installed with no headers or Jack Studs) This construction was because the addition framing was done incorrectly. Because of the height of the roof in this area there there was no room for the correct header. (Due to lack of maintenance windows are beyond repair)

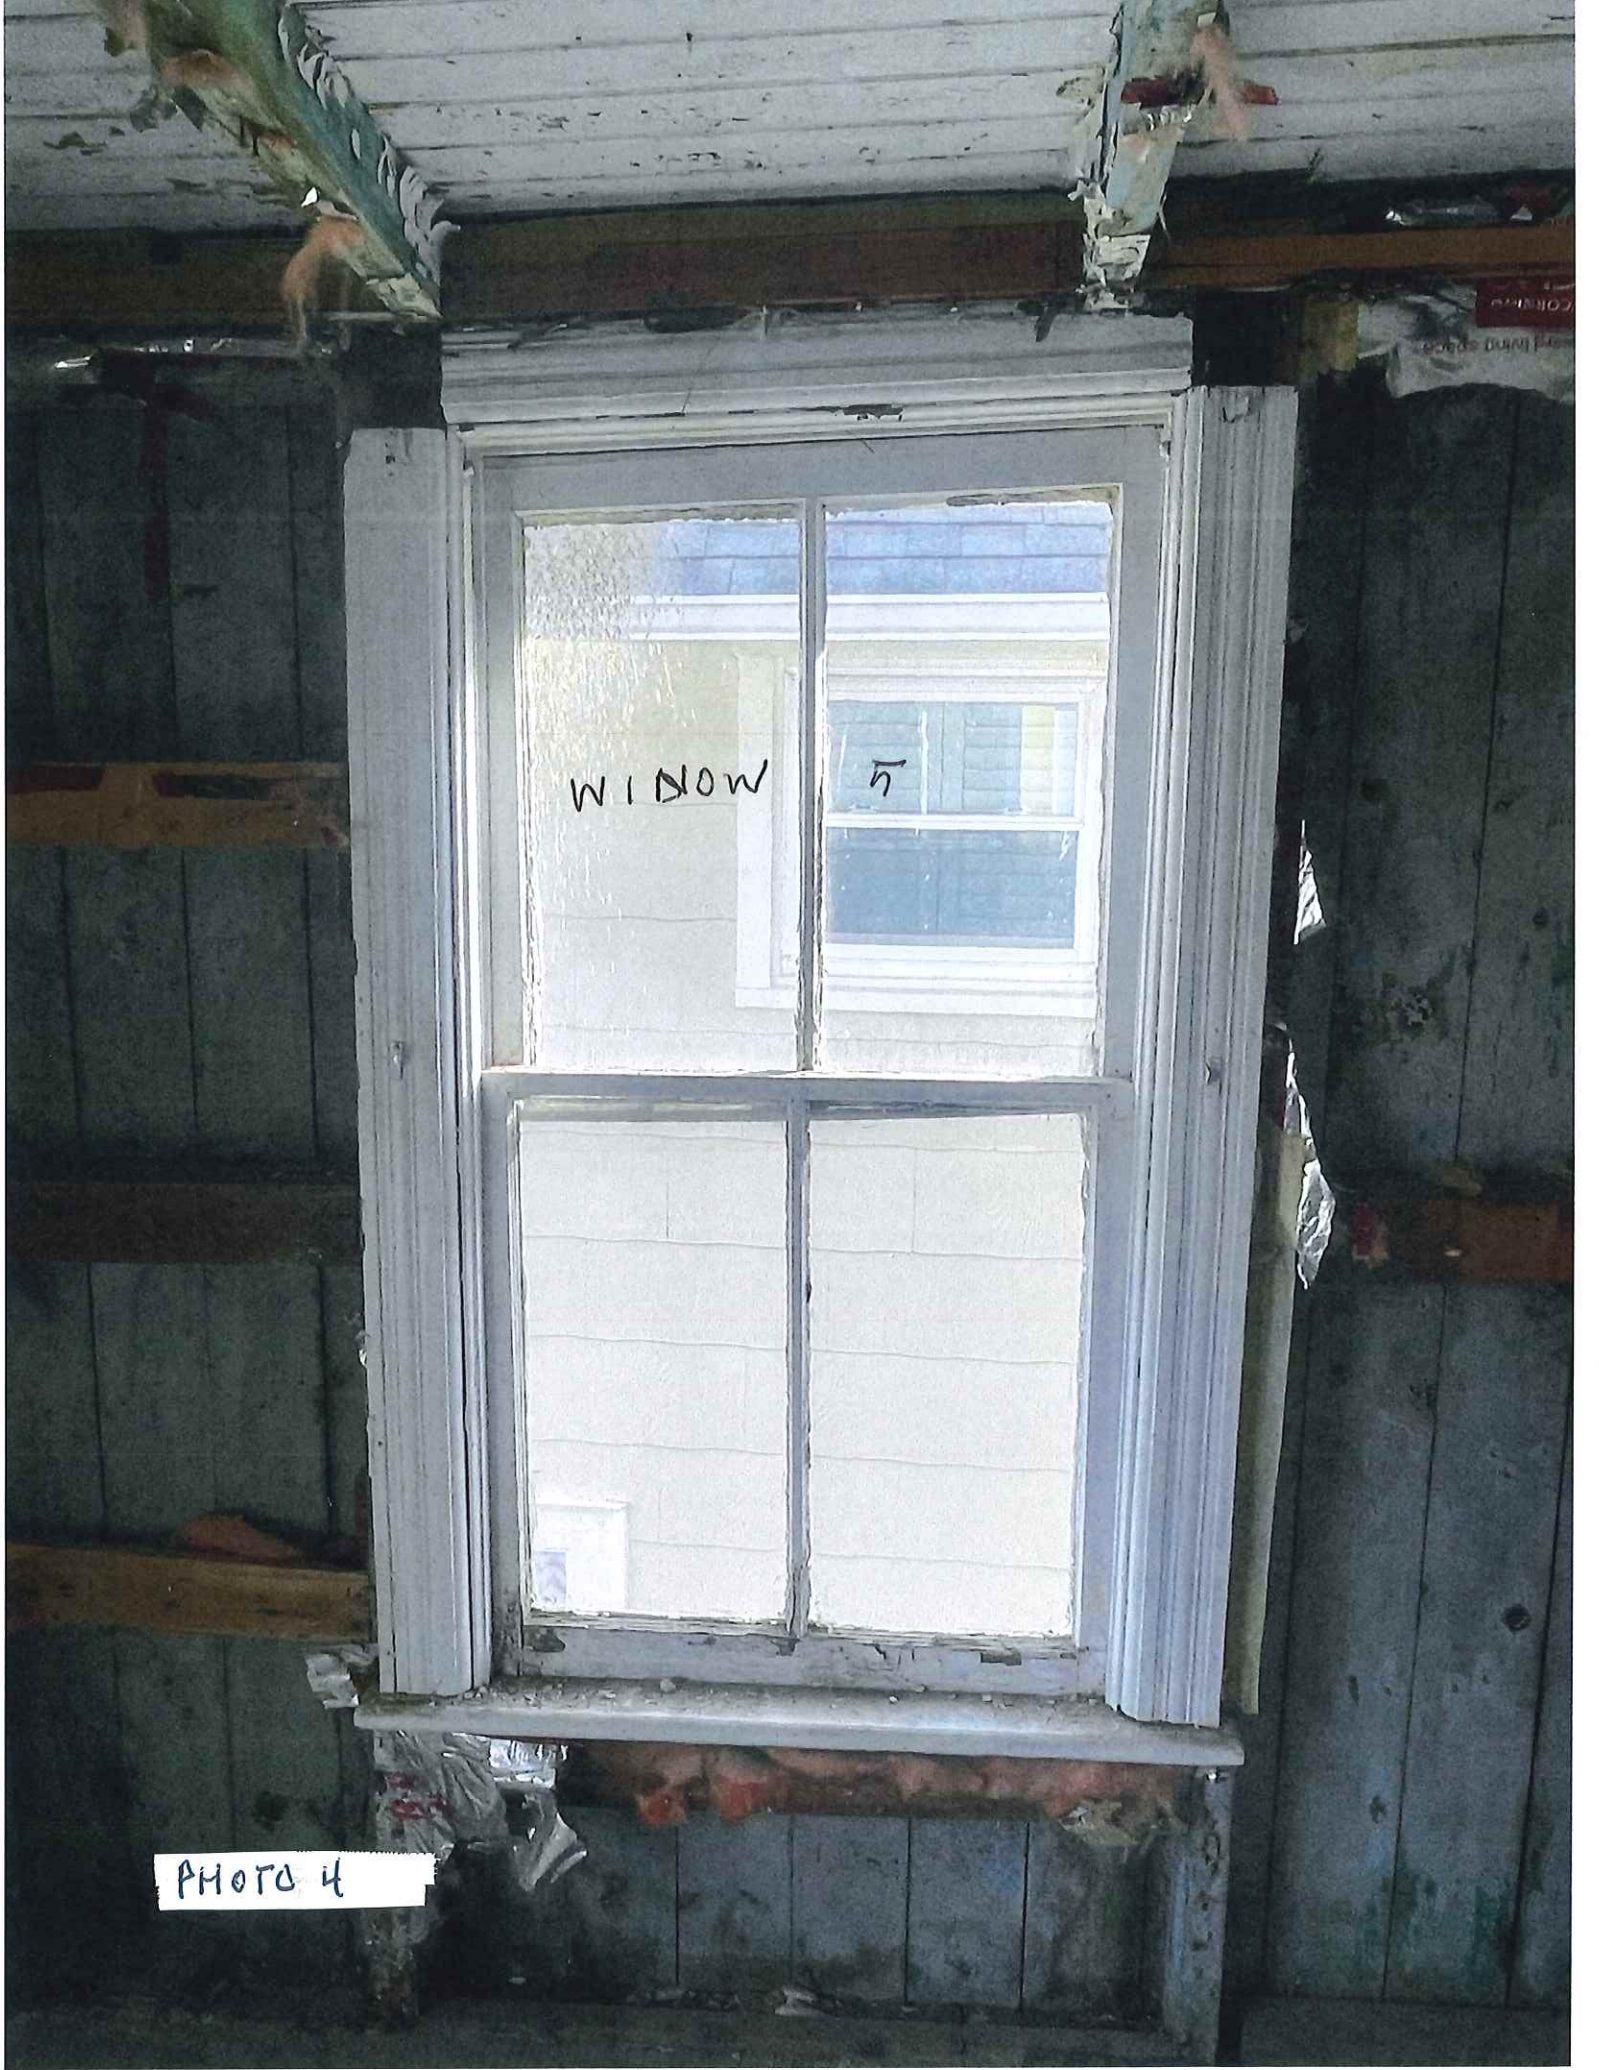
PHOTO 4

- Windows 14,15,16,17
 - All windows are double hung NOT original windows. The rear or the house was added on.
 - All Windows are in Poor condition and beyond repair.

* REPLACEMENT
WINDOW.
70-80'S ERA.

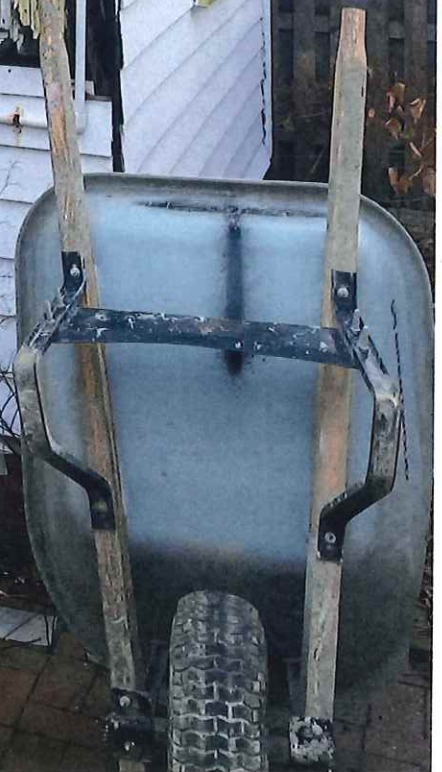
PHOTO 6

- This area of the house was an addition and not original to the house.
 - The windows are smaller in size and in a condition beyond repair
 - Window 6 Is a Modern replacement window.(Wood rotten and beyond repair

* MODERN WINDOW

← COMPRESSION
WINDOW
COUNTER BALANCE
