13 April 2022 (These notes were amended 6 June 2022 to reflect changes made by the applicant subsequent to the 19 April meeting. See Notes on pages 2, 3, 9, 10, 12, 15, 17, 22, 25, 29 & 30.)

Following OGNED's meetings before the Historic Preservation Commission (HPC) on 6 & 27 April 2021, three members—Deborah Osepchuk, Lucinda Heinlein, and Jeffery Rudell—were asked by Bernie Haney, to meet and offer feedback to the development team on ways their application (the Plan) could be brought into conformity with the Architectural Design Guidelines (Guidelines). These meetings were similar to the informal weekly Tech Review meetings available to all applicants to the HPC.

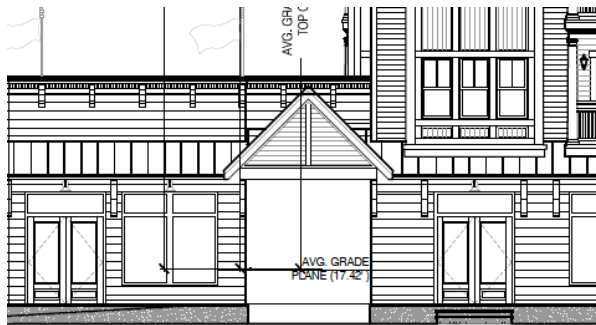
B.11. — Courtyard Corridor: At Tech’s request, OGNED agreed to reconsider the access corridor that leads from the boardwalk to the interior courtyard, to better highlight the access point and make it look more like a feature of the Retail frontage and less like an alley. At present, the pedimented entry has little relationship to the rest of the Retail area or the boardwalk itself. Tech asked OGNED to consider ways to extend that entrance forward (as a pergola or other structure extending toward the boardwalk) to better invite pedestrians into the space. The Plan presented did not activate courtyard access in any way, provided no shade, and seemed “uninviting.” No change to this area is reflected in the current Plan. **NOTE: 3 June 2022 Summary of Changes: *Windows provided in the retail spaces on both sides of the corridor passageway.***

Illustration B.11. — East elevation of proposed pediment-topped entry to courtyard corridor (Sheet A-5).

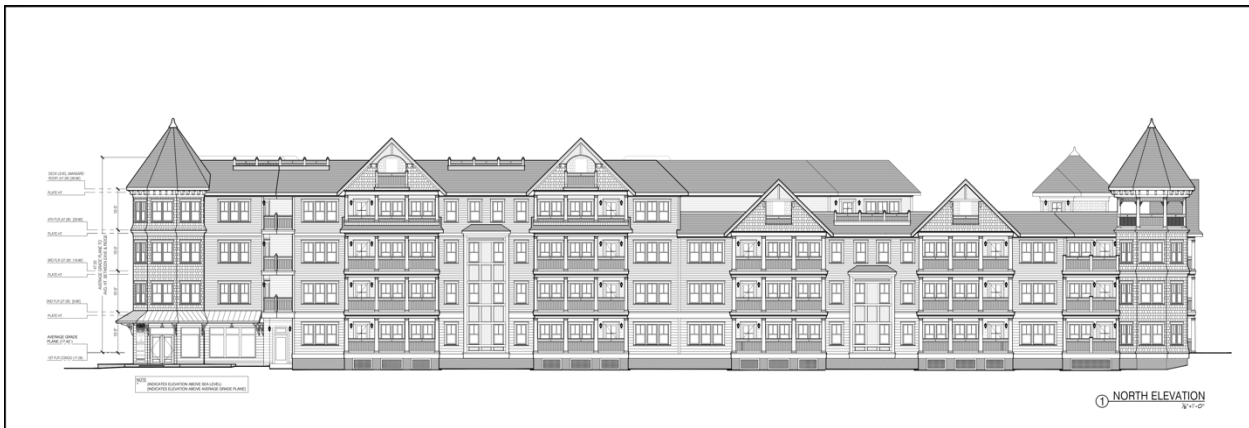
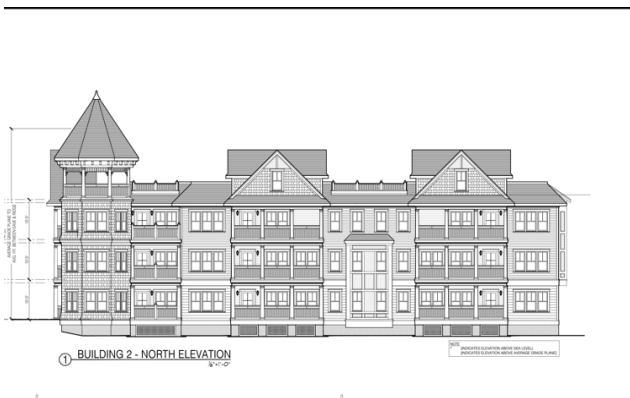
B.14. — **Condominiums:** Tech noted the proposed changes in plane on each of the Condominium buildings was minimal and provided insufficient visual rhythm, presenting instead, as a continuous wall along the north elevations facing Wesley Lake. Given the prominent lakeside location, Tech asked if the elevation of these buildings could better mimic, in scale and massing, individual townhouses.

Illustration B.14.a. — North elevation, Condominium Building One (Sheet A-6).

Illustration B.14.b. — North elevation, Condominium Building One (Sheet A-8).

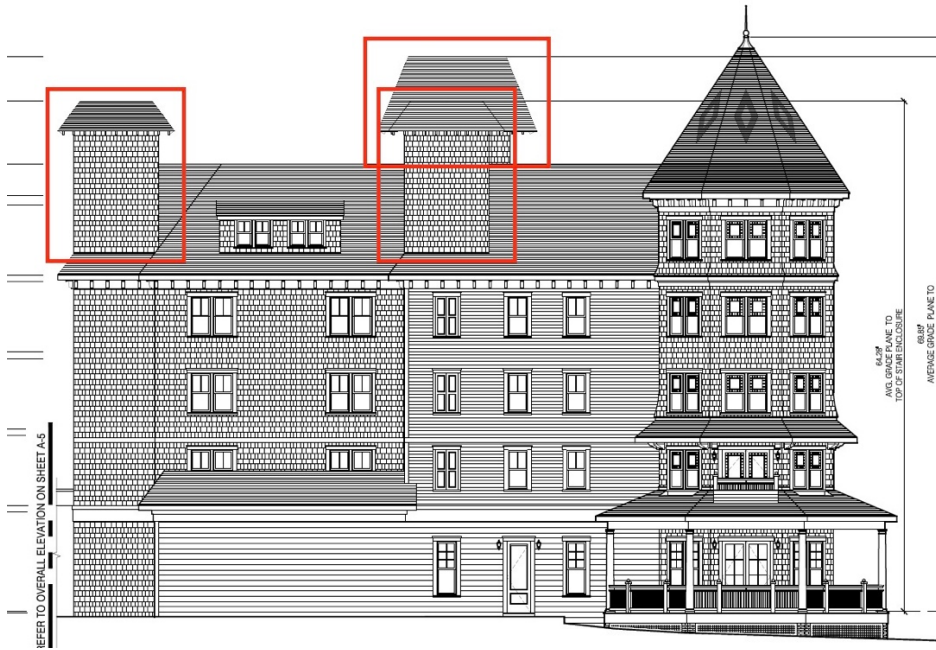
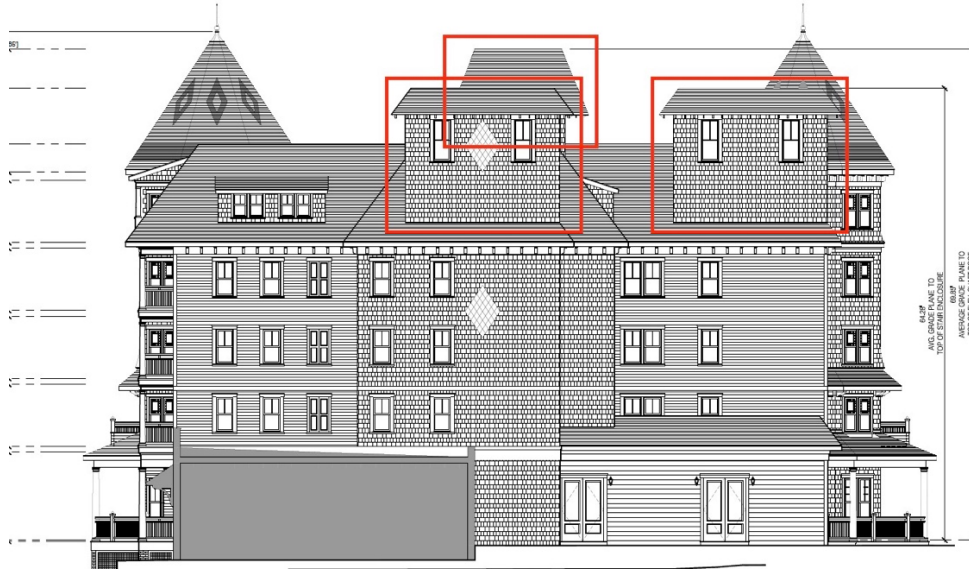
C.5. — **Hotel: Roof Projections.** Two staircase towers also serve the non-conforming roof decks and present similar design non-conformities as a result.

Illustration C.5.a. — West roof elevation of the Hotel (Sheet A-12).

Illustration C.5.b. — North roof elevation of the Hotel (Sheet A-12).

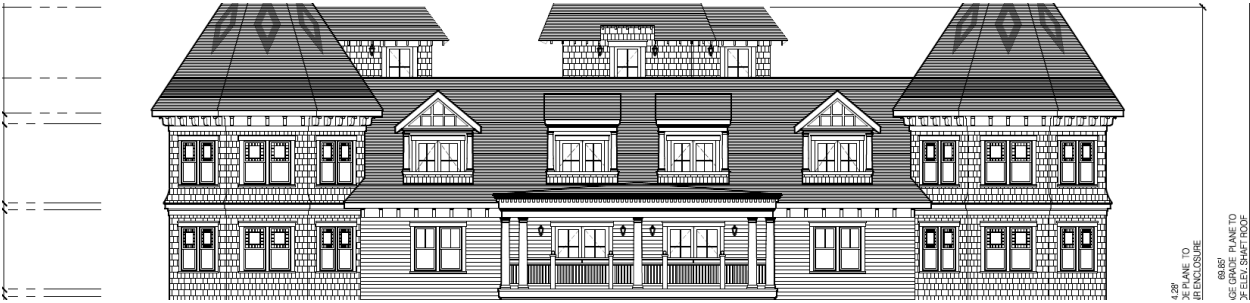
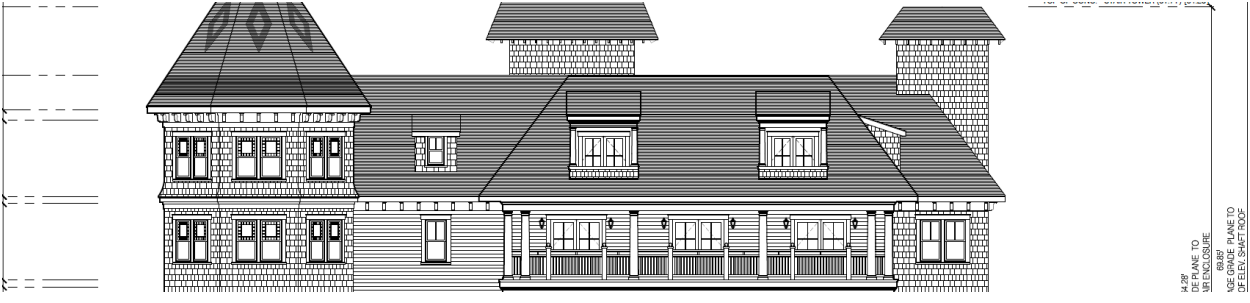
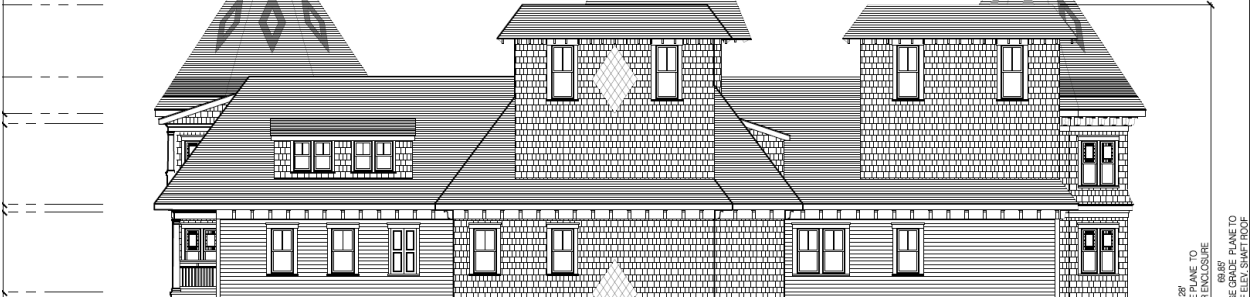
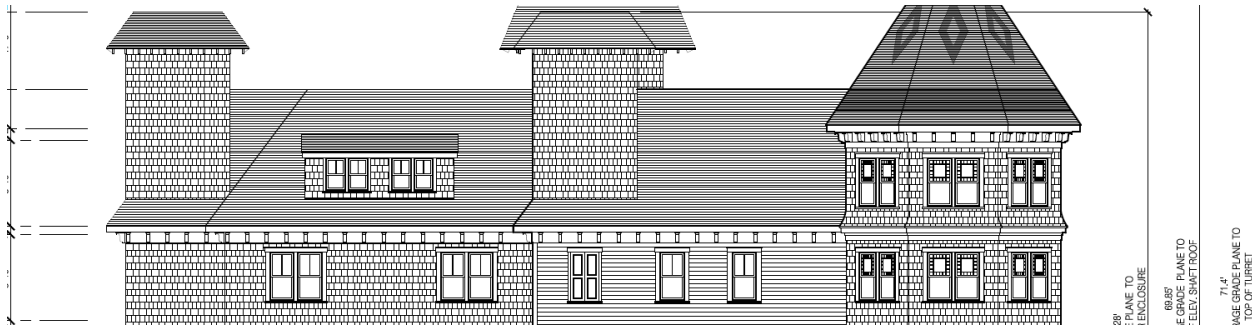
C.8. — **Hotel: Dormers.** OGNED presented designs with individual dormers, double (or paired) dormers, gabled dormers, shed dormers, and combinations of all four. Tech questioned whether mixing of dormer styles—shed and gable—magnified the weakness of secondary elements such as the proposed horizontal roofs on the elevator shaft and stairway towers. Tech suggested gable dormers would better re-enforce the verticality of primary elements such as the corner tower roofs, and be more in keeping with the Queen Anne style. **NOTE: 3 June 2022 Summary of Changes: Revised detailing at roof-top dormers. Half-size columns removed and replaced with large brackets. Dormer roof changed from shed to gable to accommodate the revised detailing. Dormer width enlarged to accommodate (1) wall lantern on each side of the doors.**

Illustration C.8.a. — Hotel dormers, south elevation, showing two sets of double doors beneath gable roofs and two sets of double doors beneath shed roofs (Sheet A-11).

Illustration C.8.b. — Hotel dormers, east elevation, showing a single window dormer beneath a shed roof and two sets of double doors beneath shed roofs (Sheet A-11).

Illustration C.8.c. — Hotel dormers, north elevation, showing two sets of double windows beneath a shed roof (Sheet A-12).

Illustration C.8.d. — Hotel dormers, west elevation, showing two sets of double windows beneath a shed roof (Sheet A-12).

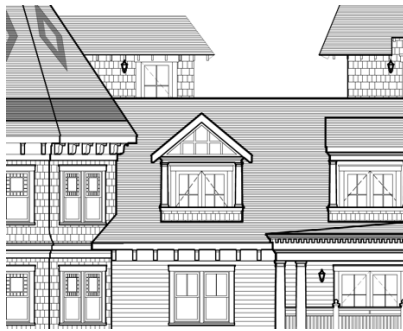
C.9. — **Hotel: Dormers.** The inclusion of paneling in the dormer gables at the south and east is historically inappropriate. Examples exist of doweled screens and orthogonal lattice in gables, but paneling of this sort is not appropriate.

Illustration C.9. — Hotel dormers, south elevation, showing proposed paneled gable ornamentation (Sheet A-11).

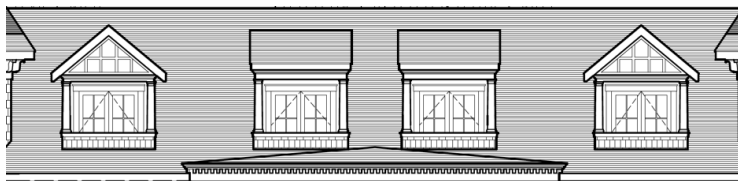
C.10. — **Hotel: Dormers.** Use of Tuscan columns on roof dormers on the south and east elevations are inappropriate. Properly scaled corbels, similar to those used at the tower balconies below the pent, are more appropriate and would help unify the design through repetition. **NOTE: 3 June 2022 Summary of Changes: Revised detailing at roof-top dormers. Half-size columns removed and replaced with large brackets. Dormer roof changed from shed to gable to accommodate the revised detailing. Dormer width enlarged to accommodate (1) wall lantern on each side of the doors.**

Illustration C.10.a. — South elevation of Hotel dormers showing proposed mini-Tuscan columns (Sheet A-11).

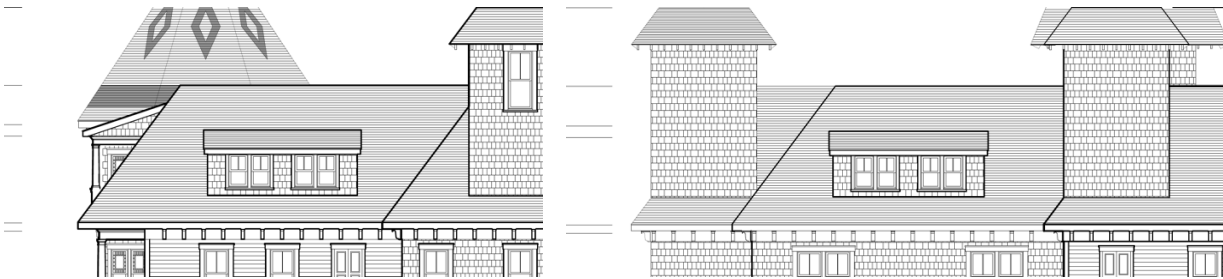
C.11. — **Hotel: Dormers.** The double dormers on the north and west should be changed to conforming individual dormers. Also, these dormers appear smaller than those at the south and east, perhaps due to them containing only windows and not doors. Please clarify.

Illustrations C.11.a. and C.11.b. — The north and west elevations of the Hotel showing proposed, non-conforming, double dormers (i.e., pop-ups) (Sheet A-12).

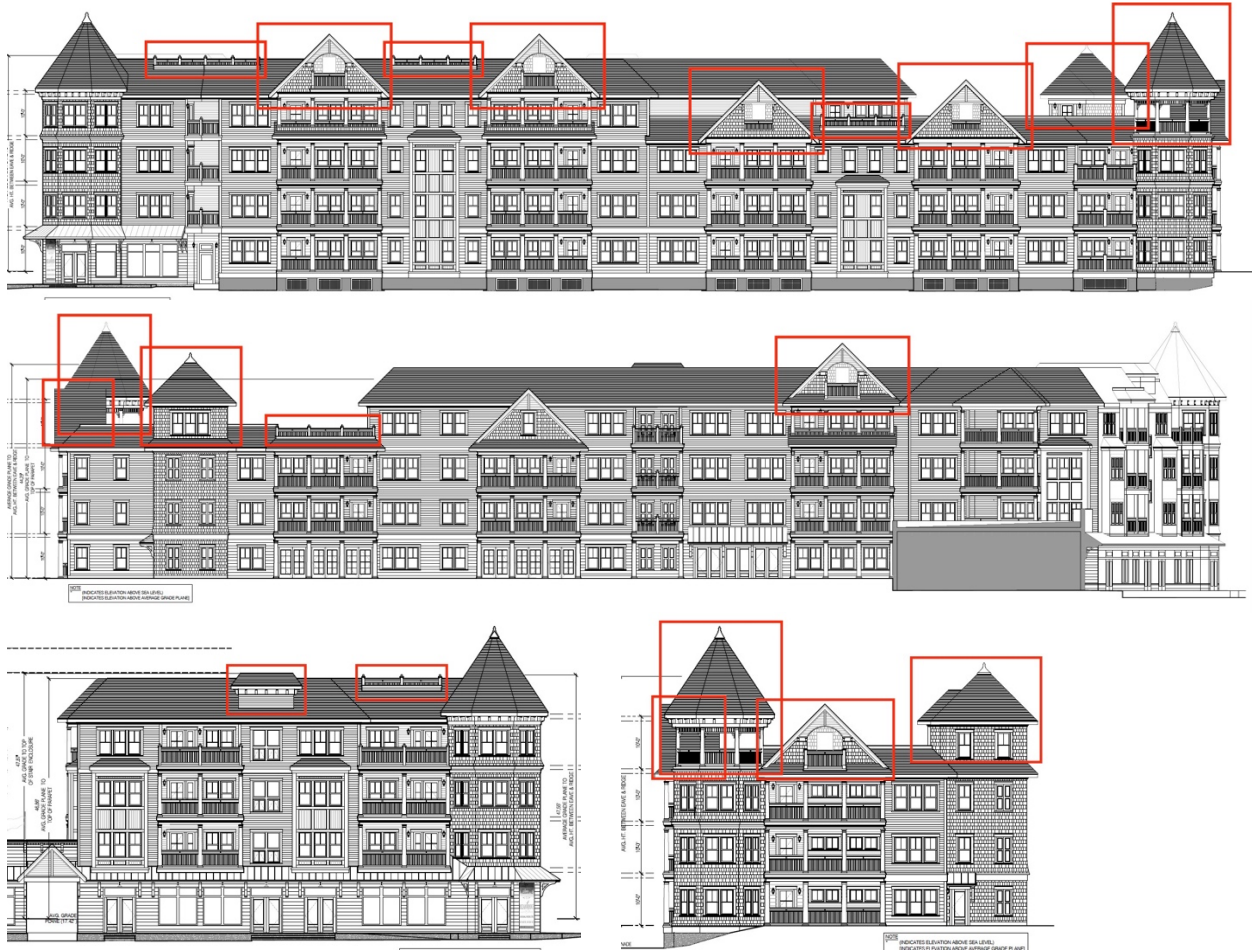
C.14. — **Condominiums:** Rather than strong, historically appropriate, roof forms, the Condominium buildings display disparate architectural elements that fail to unify or strengthen the design. These include a parapet roof meant to suggest a faux-Mansard roof, railing breaks in the parapet with short runs of newel posts and balusters, (that work against the faux-Mansard illusion), stair towers at the east and west elevations that penetrate the parapet, and unusual, non-historic faux-gables with cut-out openings, that further emphasize the non-historic roof treatment. **NOTE: 3 June 2022 Summary of Changes: Sidelights removed on porches/balconies. Removed all visible roof railings on North and East Elevations. Removed visible roof railings on Building Two. Finials added to the towers. Roof top dormers (on 3-story portion of the building) increased in depth. Roof top dormers on Building Two increased in depth.**

Illustrations C.14.a., C.14.b., C.14.c., and C.14.d. — The north, south, east, and west elevations of Condominium Building One showing non-conforming faux-gables, balusters and rails, cupola, and stair towers (Sheets

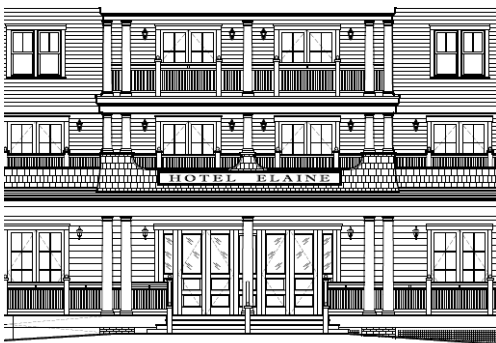
Illustration D.2. — The south elevation (Sheet A-11) showing proposed double set of double ½ doors, with non-conforming single side-light windows to the left and right.

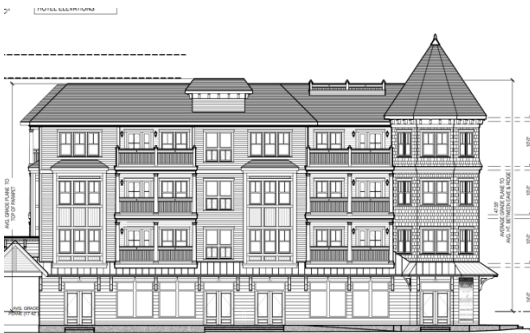
D.4. — **Condominiums:** The east elevation of Building One show single balcony doors flanked by single sidelight windows. Single sidelight windows are inappropriate. These doors should match the single doors found elsewhere on Building One and Building Two. **NOTE: 3 June 2022 Summary of Changes: Sidelights removed on porches/balconies. Single french door centered in each bay with a single light fixture located on the latch side of the door.**

Illustration D.4. — East elevation of Condominium Building One (Sheet A-5) showing single balcony doors with non-conforming single side-light windows on each of the six balconies. These balcony doors should match single balcony doors on other elevations and should not include side-light windows.

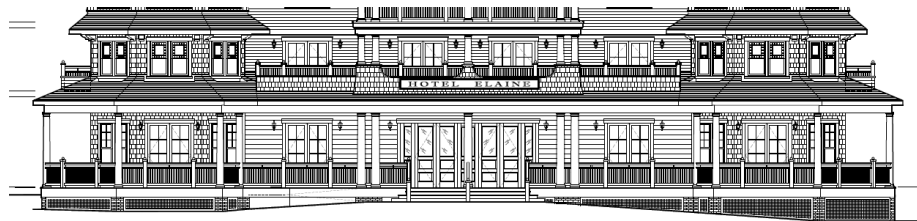
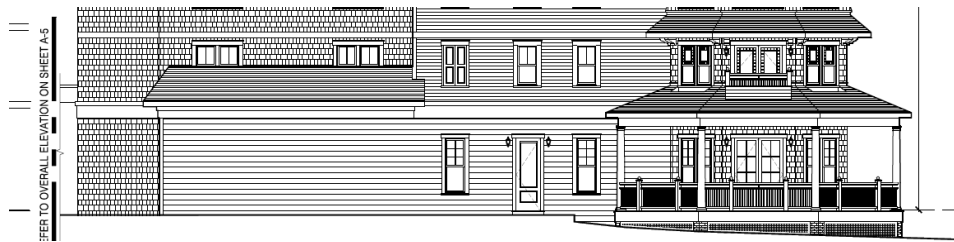
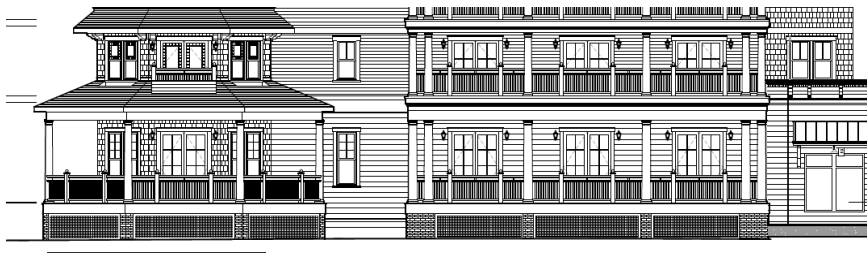
Illustration E.3.a. — First-floor, south elevation of the Hotel showing inappropriate Colonial Revival windows (Sheet A-11).

Illustration E.3.b. — First floor, west elevation of the Hotel showing inappropriate Colonial Revival windows (Sheet A-12).

Illustration E.3.c. — First floor, east elevation of the Hotel showing inappropriate Colonial Revival windows (Sheet A-12).

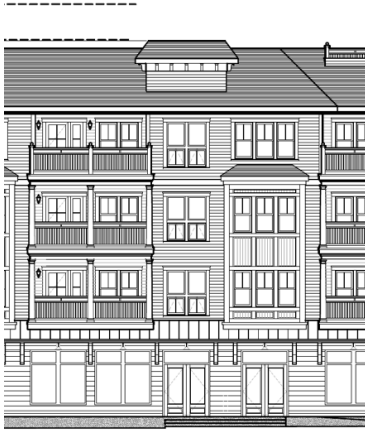
E.7. — **Condominiums:** On the east elevation of Building One, a stack of double windows in the stairwell are configured in such a way as to appear to be 1/2. This oddity gives the impression that 2/1 windows, evident elsewhere on the elevation, have been installed upside down. If these are proposed awning windows, awning windows are not appropriate to a Queen Anne design. Tech suggests a conforming solution be developed to replace this fenestration.

Illustration E.7. — Detail of staircase windows (center) configured in such a way as to suggest 2/1 windows have been installed upside down (Sheet A-5).

NOTE: 3 June 2022 Summary of Changes: *East Elevation: Smaller proportioned windows in the stair tower were removed and replaced with double hung windows to match adjacent windows.*

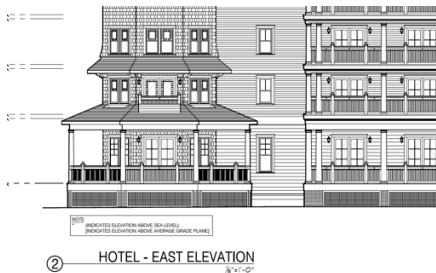
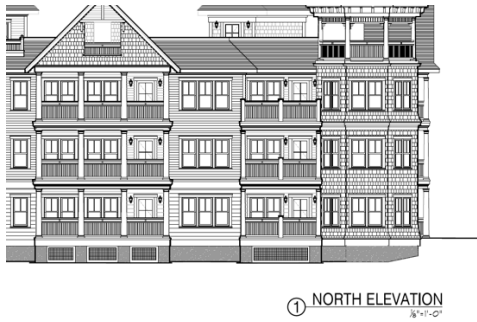
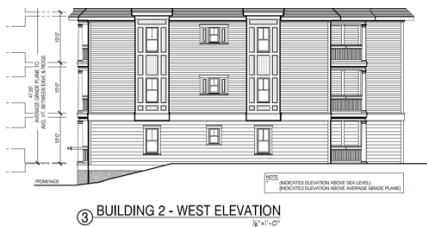
F.1. — **Hotel & Condominium Siding.** The Plan proposes cladding the Hotel with Hardie Plank with two different clapboard reveal dimensions: wide on the first story and narrower on the upper stories. Mixing clapboard reveal sizes is sometimes found on historical examples, but only rarely, and only to highlight important architectural features. No such highlighting of architectural features is present in the proposed Plan. Uniform dimensions of clapboard reveals should be used, instead.

Illustration F.1.a. — East elevation of the Hotel showing proposed clapboard reveal at first floor (wide) and upper floors (narrow) (Sheet A-11).

Illustration F.1.b. — North elevation of Condominium Building One showing proposed clapboard reveal at first floor (wide) and upper floors (narrow) (Sheet A-6).

Illustration F.1.c. — West elevation of Condominium Building Two showing proposed clapboard reveal at first floor (wide) and upper floors (narrow) (Sheet A-8).

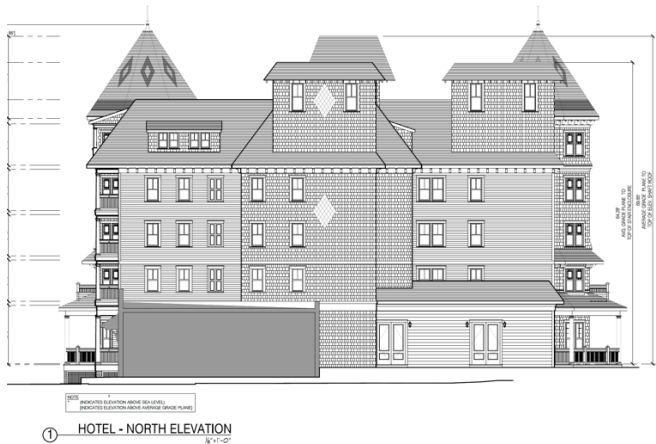
Illustration F.4. — North elevation of the Hotel showing over-sized diamond patterns in shingled cladding. (Sheet A-12).

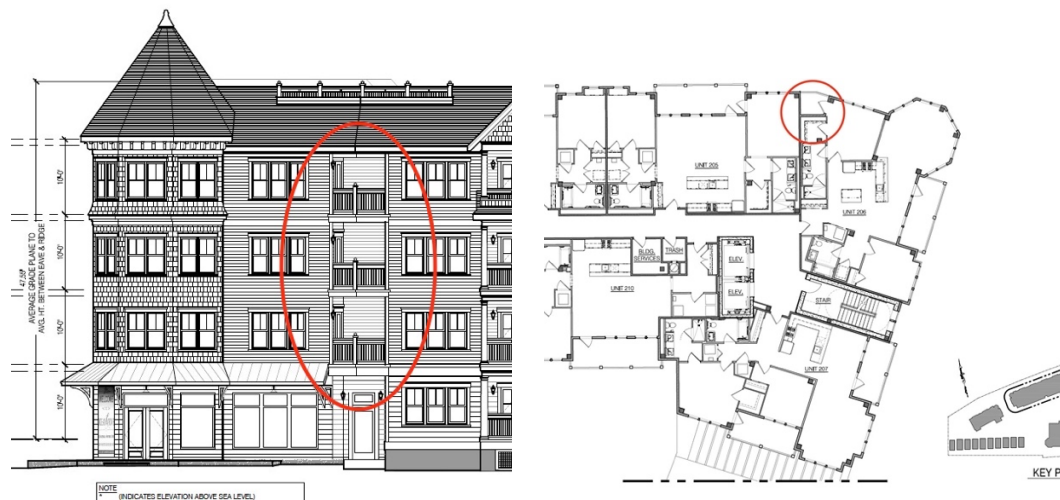
G.5. — Condominiums: At the north elevation, just west of the Building One tower, above the north access door, are a row of inset-balconies. These balconies occur at the point where the building jogs southwest along Wesley Lake. These balconies are five-sided, due to a bend in their railings, have no windows, single doors, and no lighting. They are non-historic in character, awkward in size and placement, and differ in every way from any other balcony in the project. Tech recommends they be reconsidered or eliminated. **NOTE: 3 June 2022 Summary of Changes: Shutters added at inset balcony on the North East corner.**

Illustrations G.5.a. and G.5.b. — Detail of northeast corner of Condominium Building One showing windowless mini-balconies above the north building access door (Sheet A-6). These balconies are circle in the second-floor plan, at right (Sheet A-2).

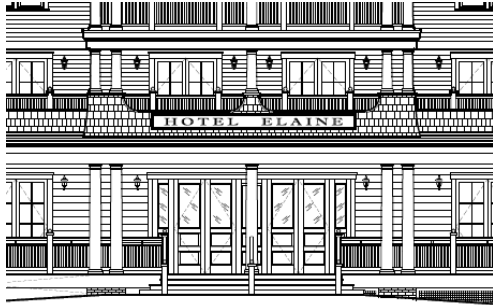
H.1. — **Hotel:** The main entrance stair of the Hotel is bisected by a singled porch column yet flanked by double porch columns. Elimination of the single column is recommended to better frame the entrance.

Illustration H.1. — Hotel entrance flanked by double columns with single column bisecting the entry area (Sheet A-11).

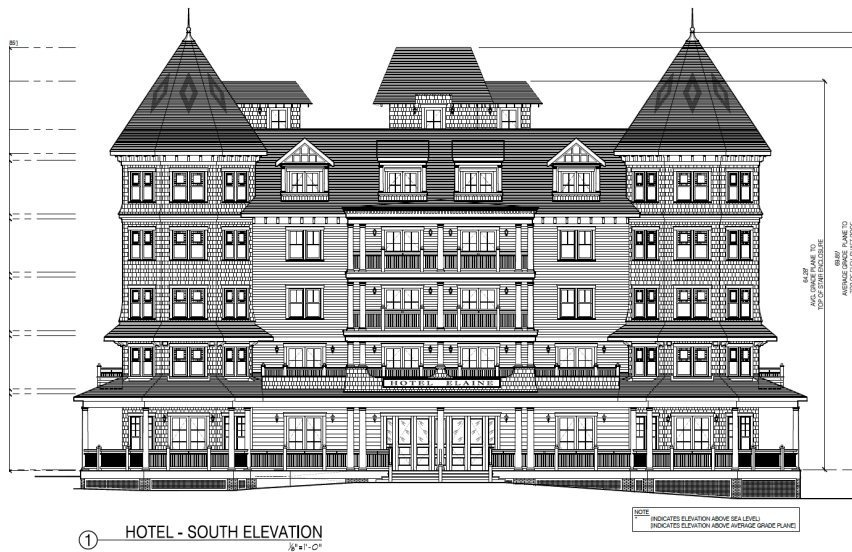
H.3. — **Hotel:** Diamonds and banding on tower roofs is over-scaled.

Illustration H.3. — Roof tile patterns showing oversized diamonds and banding (Sheet A-11).

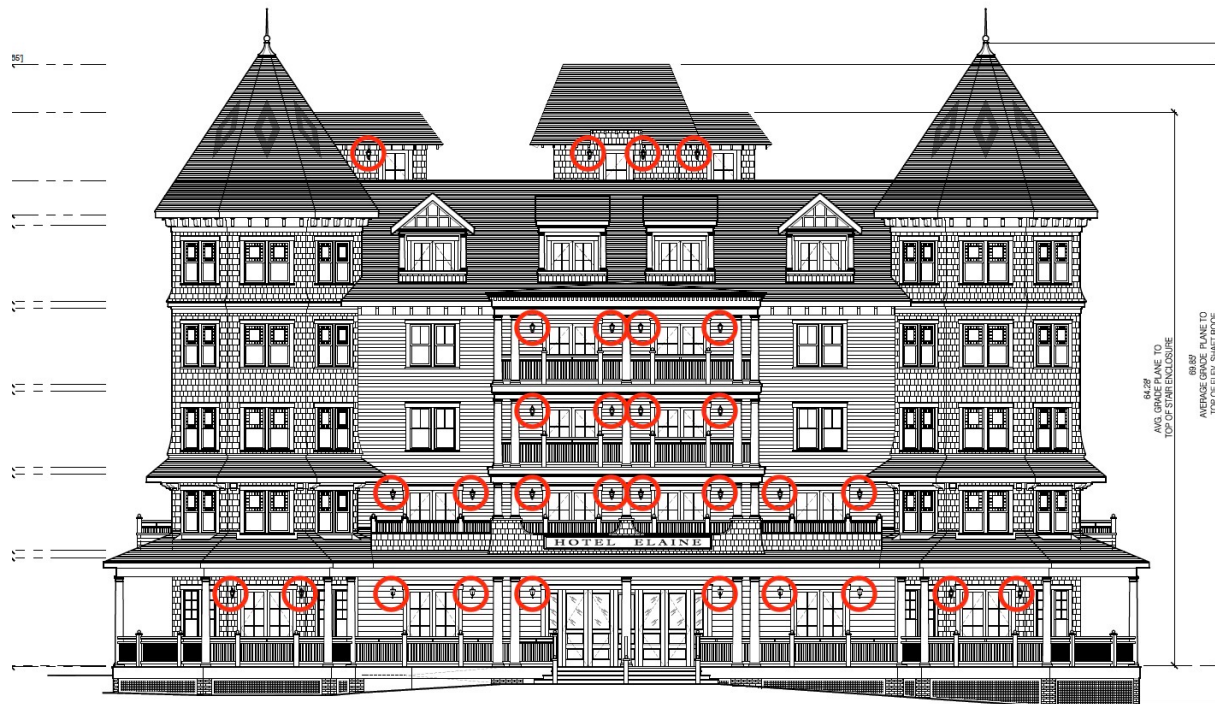
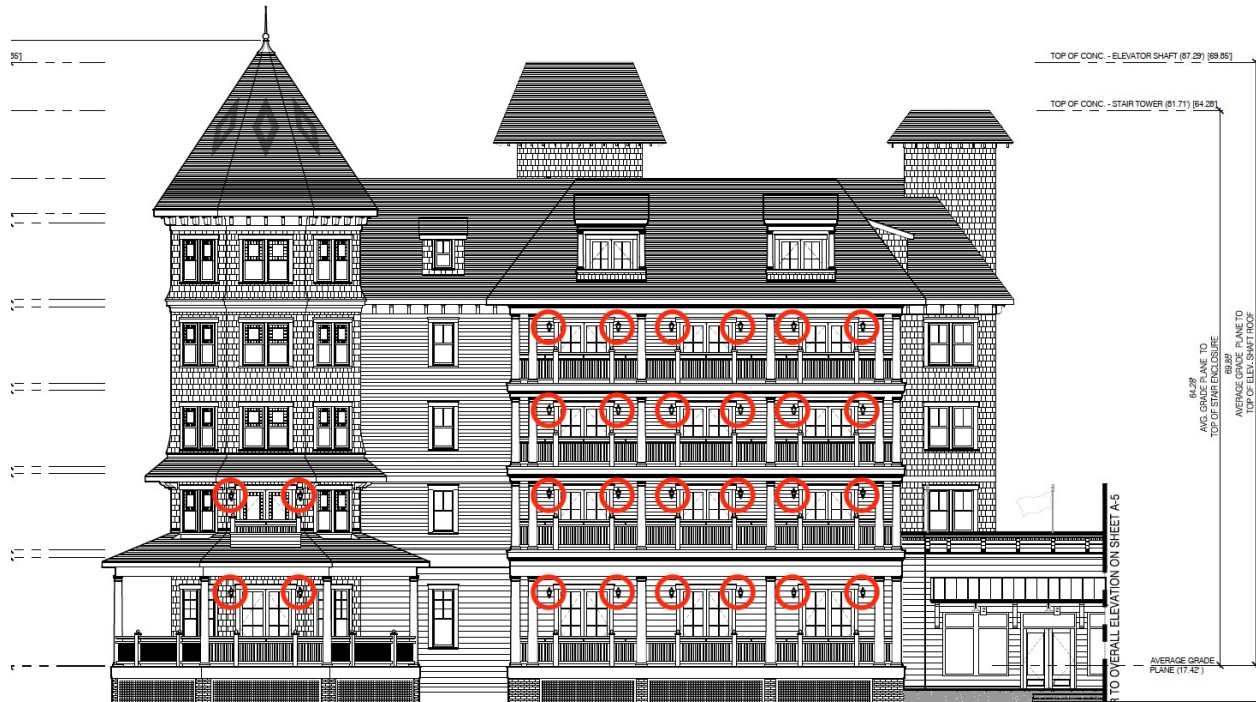
I.4. — **Hotel:** The south elevation of the Hotel indicates thirty (30) lanterns, including four on the roof projections, with an additional twenty-eight (28) lanterns on the east elevation, facing the boardwalk. In contrast, the west elevation shows only six (6) lanterns. Tech considers the number of proposed lights excessive to a degree that is typically modern and recommends that lighting at the south and east elevations be reconsidered. **NOTE: 3 June 2022 Summary of Changes: Revised detailing at roof-top dormers. Half-size columns removed and replaced with large brackets. Dormer roof changed from shed to gable to accommodate the revised detailing. Dormer width enlarged to accommodate (1) wall lantern on each side of the doors.**

Illustration I.4.a. — South elevation of the Hotel showing thirty (30) proposed lantern fixtures (Sheet A-11).

Illustration I.4.b. — East elevation of the Hotel showing twenty-eight (28) proposed lantern fixtures (Sheet A-11).

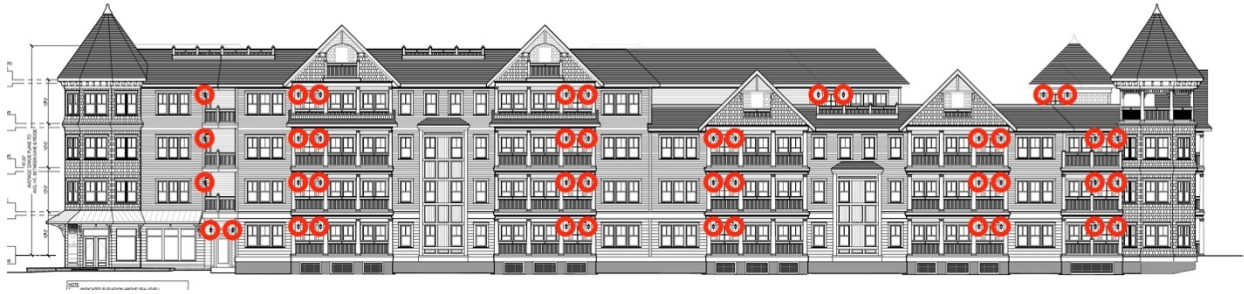
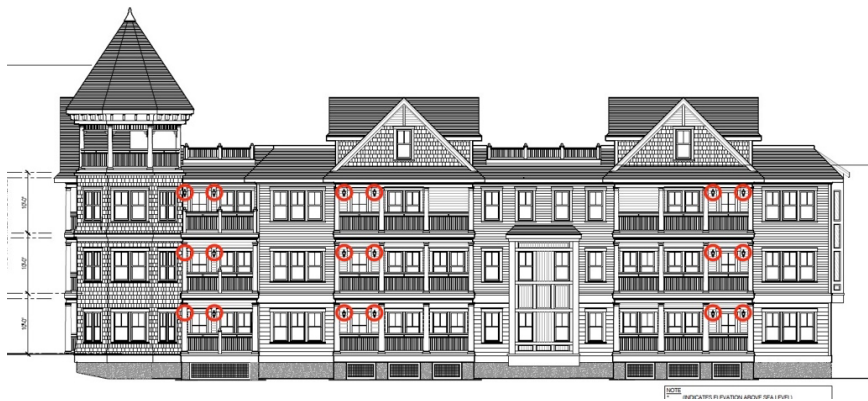
I.2. — Tech considers the lighting on the current plan excessive, with two lights per balcony in most cases. Because of the abundance of lighting the project will likely fail to blend appropriately into its neighborhood.

Illustration I.8.a. — North elevation of Condominium Building One showing lighting (most of which entails two light fixtures flanking single doors onto balconies) (Sheet A-6).

Illustration I.8.b. — North elevation of Condominium Building Two showing lighting (all of which entails two light fixtures flanking single doors onto balconies) (Sheet A-8).

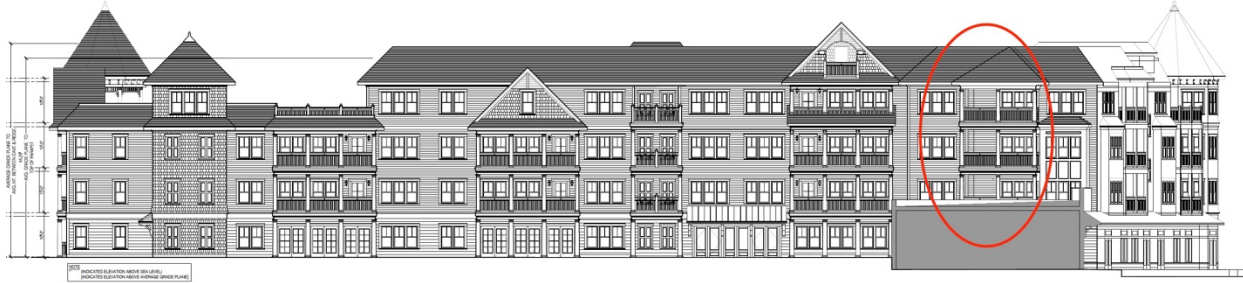
I.10. — **Condominiums:** The lighting, while excessive, also appears inconsistent (e.g., no lighting is indicated on Condominium Building One, south elevation, in the stack of balconies directly above the Retail space).

Illustration I.10. — South elevation of Condominium Building One showing balconies with no lighting indicated.
