51 Webb Ave, Ocean Grove
Window Report

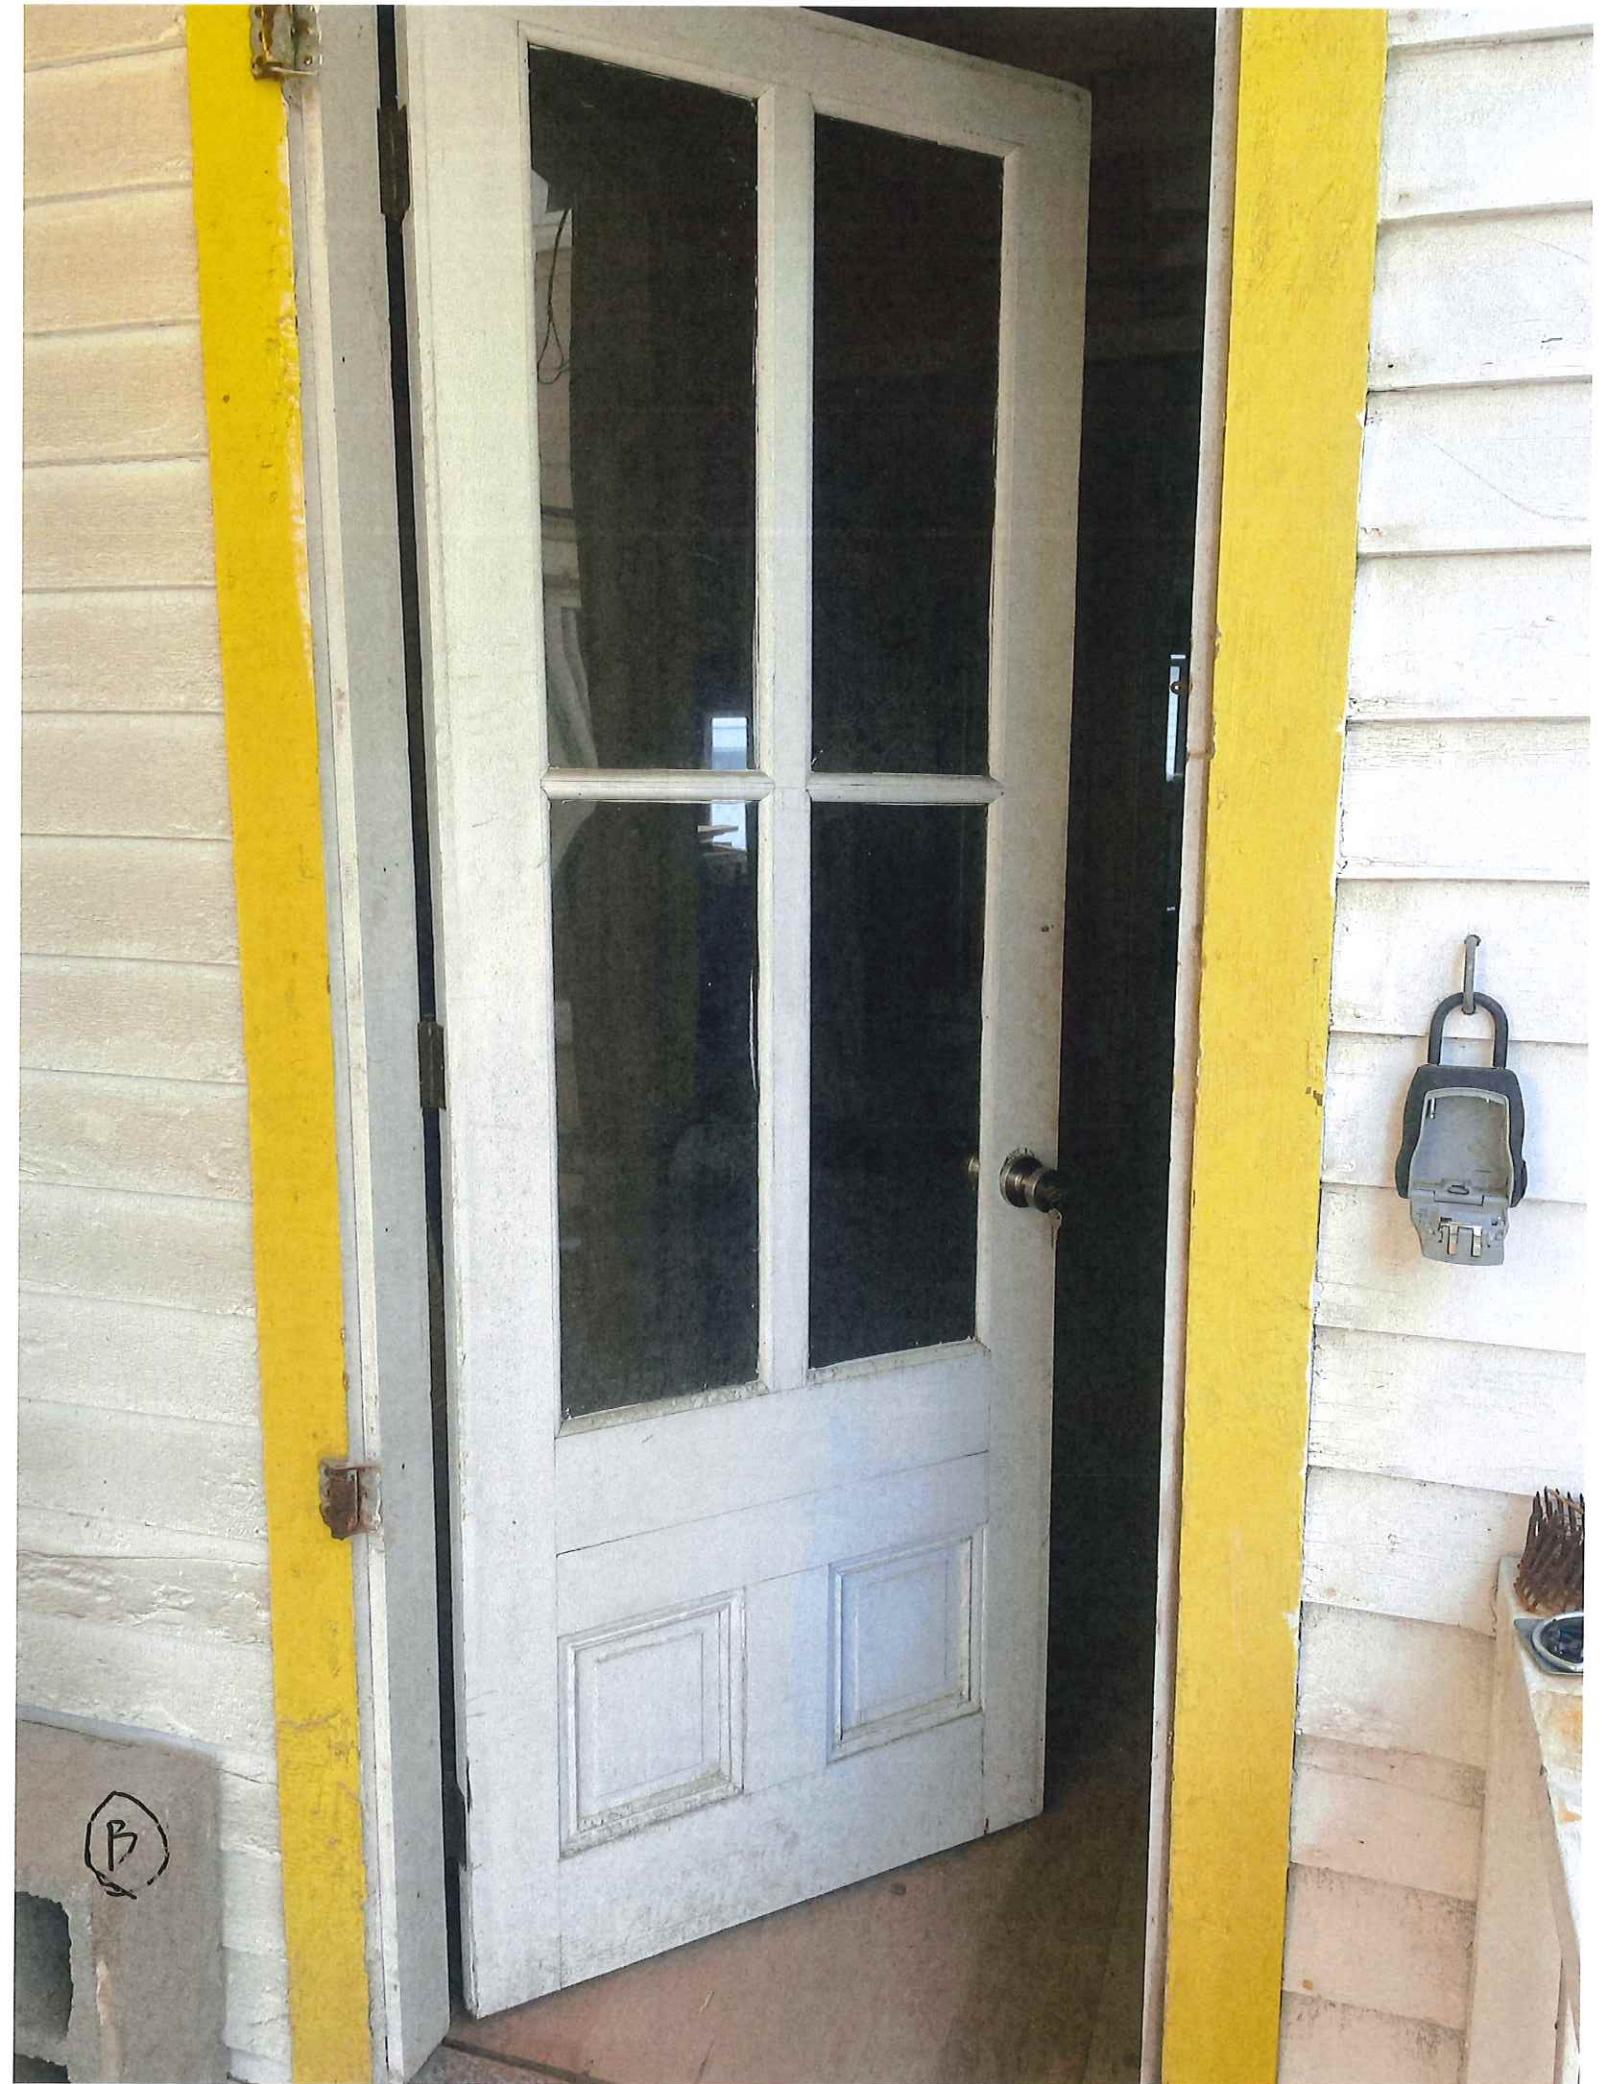
PHOTO 8

- Window 13 seems to be and original widow with size and style. Condition is poor and beyond repair(See Photo 8)
 - Windows 7&10
 - These are newer Casement style windows that look to be installed during a previous renovation.(Window conditions are poor and beyond repair)

Over all Condition of windows are Poor and beyond repair. We propose to replace all windows with Anderson 400 Series windows Matching the size of the "Original" Windows.
